**CONSERVATION OF ARCHITECTURAL MARBLE AT
THE NEW YORK PUBLIC LIBRARY**

Timothy Allanbrook¹ and Andrew Wilson²

¹ *FAIA, Senior Principal, Wiss, Janney, Elstner Associates, Inc.*

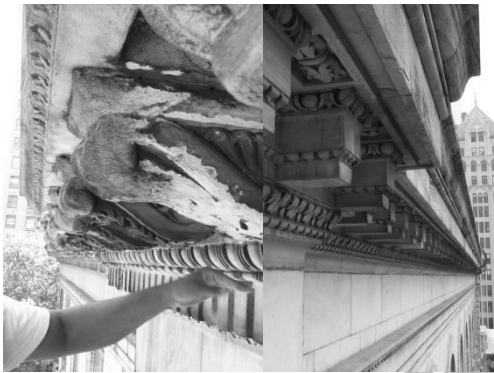
Figures 5a and 5b. Deteriorated modillions at main cornice without drip groove (left) and sound modillions at high cornice (right) with drip groove.

5a and 5b). A lead coated copper cornice ledge cover with a formed drip edge was specified to correct this problem for the future.

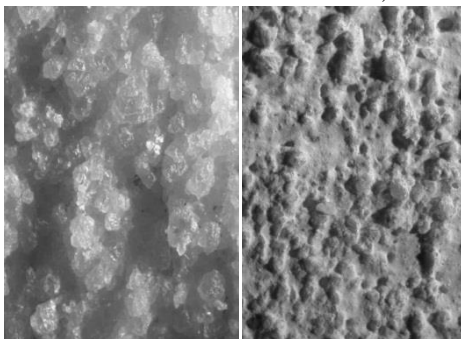
Figures 6a and 6b. Photomicrograph of disaggregated marble crystals before (left) and after treatment (right).

ammonium oxalate were evaluated both in the laboratory and later, through field trials on friable surfaces. To further protect the eroded surfaces, a lime based shelter coat was applied over the oxalate-protected surfaces. This method proved to be quite compatible with the marble substrate and in the end, provided a viable level of sacrificial protection to the material substrate (Figure 6a and 6b).

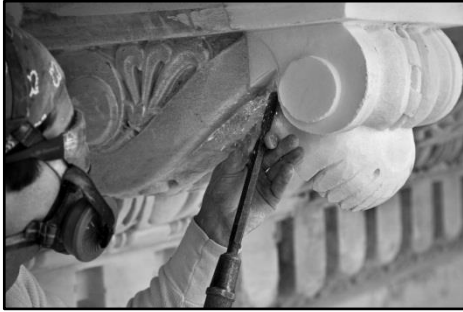
Figure 7. Marble dutchman patches were carved in place

Dutchman patch repairs are generally considered to be an appropriate restoration technique in the repair of distressed architectural stone work, particularly where stone elements are missing or are too severely deteriorated for other repairs to be effective. Some two thousand dutchman repairs were executed in the course of the work (Figure 7).

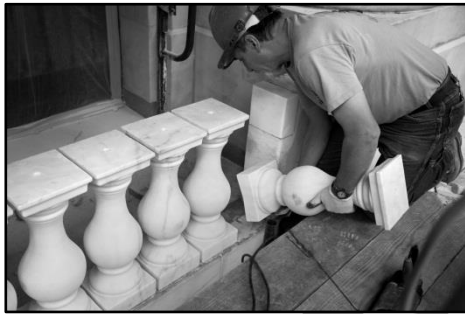
Figure 8. New turned marble balusters were installed at all balconies and parapets

Localized stone repair & replacement work was then conducted (Figure 8) along with the fine arts statuary conservation & cleaning work. Stone treatments such as the Ammonium Oxalate and Lime Shelter coats were then applied and a final wash-down performed. Final inspection, cleaning and/or treatment adjustments, and installation of bird netting in selected areas wrapped up the work in any given area. Due to the size of the building many of these procedures were being performed simultaneously at various areas.

Stone veining in the new replacement stones, while acceptable in ashlar units, became very prominent, and usually unsightly in the turned balusters. Unfortunately this was not detected during the submittal phase because the full size baluster samples submitted coincidentally did not have veins. This issue required replacement of many brand new balusters prior to installation.

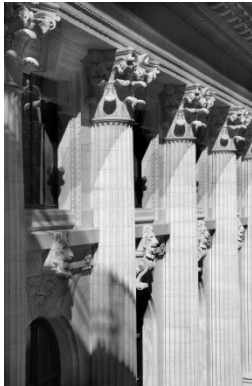
Figure 9. Detail of completed front facade

Then, during the three-year construction period, members of the preservation team made repair and treatment decisions on a stone by stone basis ranging from crack fills to more than 2,000 carved dutchman patches (Figure 9). This was truly a career topping project for all parties involved.
