WEATHERING, CONSERVATION AND RESTORATION OF THE SANTA MÓNICA CHURCH IN GUADALAJARA, MEXICO

Karla Jáuregui Arreola¹, Wanja Wedekind² and Siegfried Siegesmund²

Abstract

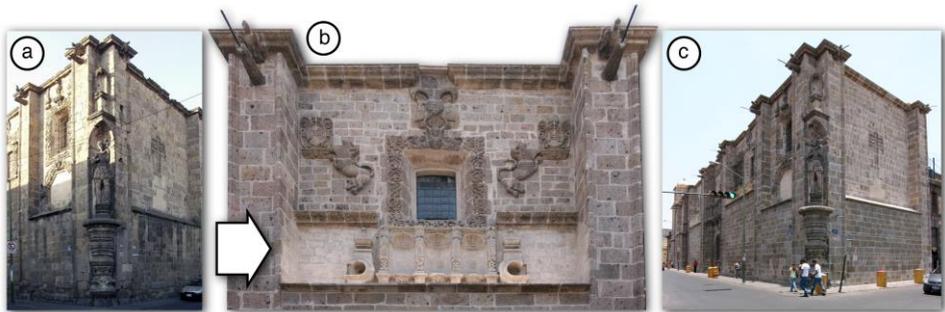
Figure 1. a) Church before restoration. b) Area where architectural elements were discovered (arrow) that include three niches for the placement of religious sculptures. c) Church after restoration.

After these two catastrophic events protection walls up to 7 meters in height were erected between the pillars, which subdivides the façade. By the removal of the upper parts of these protection walls during the restoration in 2009, large-scaled areas rich in decorations were discovered.

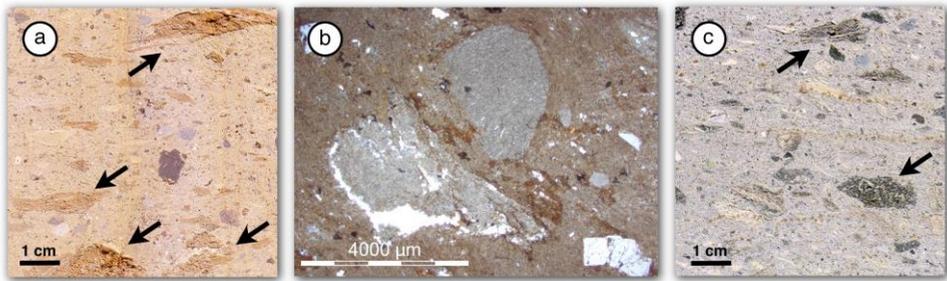
Figure 2. a) The Cantera Amarilla Tuff shows a secondary iron-rich cementation with a vertical orientation and brown iron-rich pumice inclusions (arrows). b) Thin section showing the glassy to microcrystalline matrix. In the center a fragment of feldspar and pumice occurs that only shows a poor cementation within the matrix. c) Cantera Amarilla with dark colored inclusions, rock fragments and pumice (arrows).

The Cantera Amarilla Tuff belongs to the Quaternary volcanics in the Guadalajara area occurring one to two meters beneath the soil. Today most of the deposits are covered by the present urban area. Only a small outcrop is still open for mining the stones for restoration purposes. The rock is a yellowish to orange-brownish porphyritic tuff containing clasts with very different sizes (Fig. 2a and b). The clasts are poorly flattened, light brown to brownish-red pumice and other lithoclasts, which are fine- to medium-grained (sand size), up to 10 cm or even coarser. Most of the pumice inclusions are not well-cemented to the matrix (Fig. 2 b).

The thin section in Fig. 2b shows a hypocrySTALLINE to aphanitic texture. The matrix is reddish to yellowish, glassy to microcrystalline and poorly welded. The macroclasts are mainly pumice, but other lithic clasts such as basalt and other pre-existing volcanic fragments occur. Crystals are essentially platy and tabular and subhedral to euhedral. They consist of well-twinned alkali-feldspar phenocrysts, subrounded to angular reworked quartz and unidentified opaque crystals.

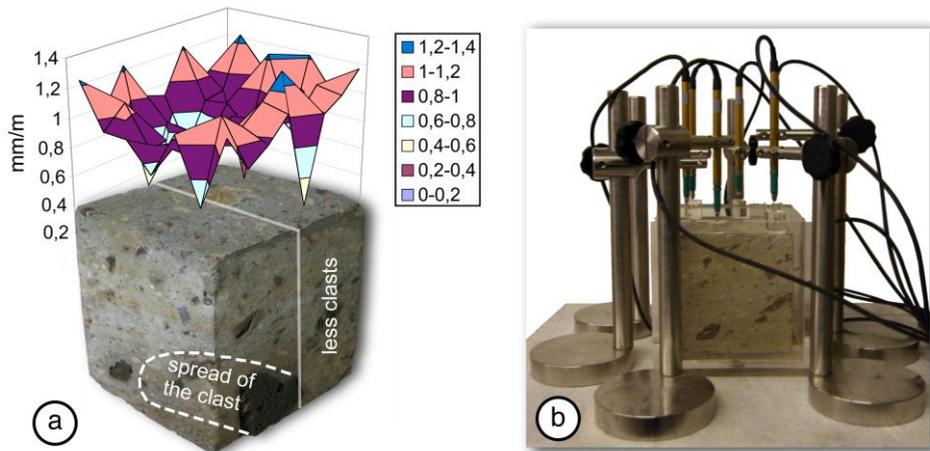
The results of the dilatation experiment on the stone block emphasize the influence of the bedding towards moisture expansion. What becomes clear is that the periphery of the stone shows a higher moisture expansion than the center of the block (Fig. 3a). Furthermore, the large pumice inclusions seem to play a role in keeping the moisture values low. Above the large inclusion there is also a tendency to lower dilatation values, probably due to the lower amounts of matrix. In the sample cube where the concentration of clasts are lower, the dilatation is higher (Fig. 3a).

Figure 3. a) Stone block and results of the dilatation experiment. b) The measuring equipment.

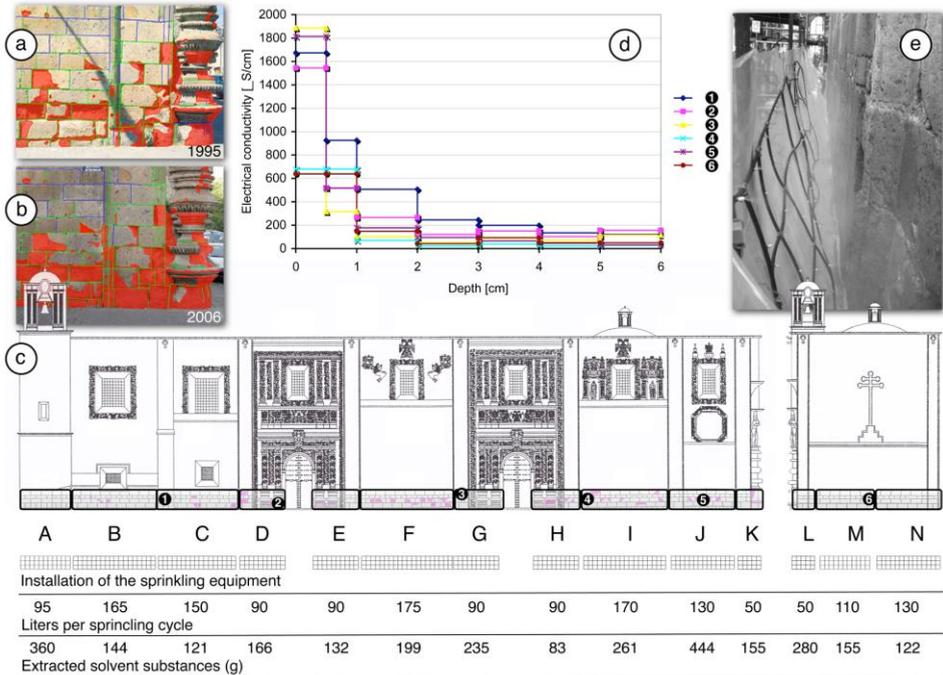
In the foundation area of the Santa Mónica Church as well as other historical buildings extensive back-weathering due to disaggregation and distinct fragmentation is observable. Mapping results indicate a yearly back-weathering rate of 1.7% in the foundation area (Fig. 2a & b). Most of the stones concerned were installed like plates, which means perpendicular to the bedding. Salt efflorescences are recognizable on many building stones. The main salt found is sodium nitrate (NaNO_3) and gypsum analysed by X-ray diffraction (XRD) measurements. The highest concentration of contamination occurs in the first two centimeters of the stone material as evaluated by the drilling powder analysis method (Fig. 4d).

Figure 4. a) Degree of back-weathering in 1995 and b) around 10 years later in 2006. c) Architectural drawing of the façade. Areas for desalination (A-N) and sampling points for drilling powder analysis (1-6) are indicated. The schematic grid depicts the location of the sprinkling equipment. Quantities of water used and the amount of dissolved substances extracted are given below. d) Salt contamination with depth. e) The sprinkling equipment being applied.

For salt reduction a sprinkling method was applied, which was developed for the desalination of salt-contaminated areas on rock cut facades in Petra/Jordan (Wedekind, Ruedrich 2006). In front of the contaminated areas of the church a grid-like system consisting of pipes was installed (Fig. 4e). Each pipe contains a nozzle and was placed at a distance of 40 cm to the next one. At the bottom of the wall a sheet of plastic was cemented in a horizontal joint to catch and drain the excess water. The façade was

divided into 14 areas from A to N (Fig. 4c). During the desalination process water is sprayed onto the wall surface through the nozzles. Water absorption occurs immediately into the porous stone surface. Depending on the sprinkling duration, a little or more water seeps into the stone, whereby the depth penetration can be adjusted accordingly. The water not absorbed by the stone runs off the wall, is drained in a controlled way and sampled. Electrical conductivity is measured in a 5 liter container to determine the influence of dissolved substances.
