**MARBLE STATUES AND PANELS OF SAN PETRONIO FAÇADE IN
BOLOGNA – STATE OF CONSERVATION AFTER 40 YEARS SINCE
RESTORATION**

Abstract

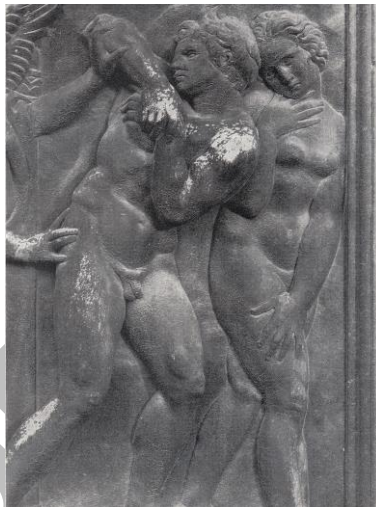
The church underwent over time several restructuring and restoration interventions. The first documented restoration on the stone façade was conducted by the restorer Ottorino Nonfarmale from 1972 to 1979. At that time the facade was covered with a dark, compact, homogeneous crust detached only in some jutting out and exposed areas. In some sculpted parts of side portals, pieces of carved stone had fallen off (Fig. 1) (C. Gnudi, R. Rossi Manaresi, O. Nonfarmale, 1979).

Fig. 1. Panel depicting “The Expulsion from the Garden of Eden” before the 1970s restoration (R. Rossi Manaresi, 1981). The dark crust homogeneously covering the stone had fallen off in some of the most exposed areas.

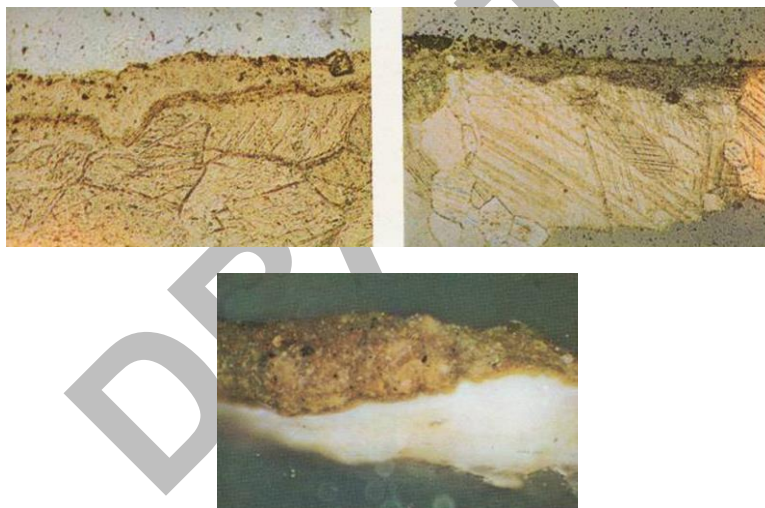
The analyses carried out on samples from panels and sculptures of the central portal showed that the marble was generally well preserved and still compact, and a dark superficial crust was distinctly overlying on it (Fig. 2) (C. Gnudi, R. Rossi

Fig. 2. Cross-sections of samples from central portal. The division between the dark crust and the underlying stone is clearly distinct (R. Rossi Manaresi, 1981).

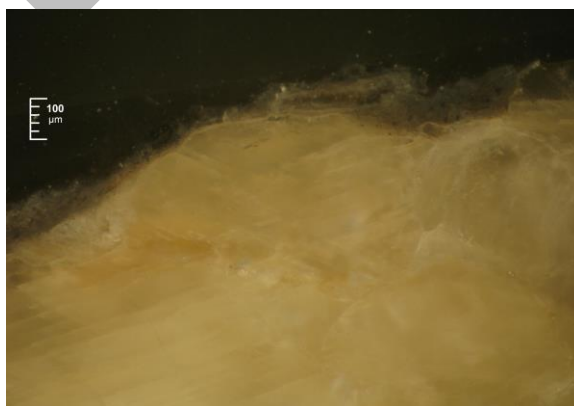
Fig. 3 shows the cross section of a fragment taken in the 1970s from the back of the basement of St. Ambrogio statue (main portal). In the visible light image a patina, composed by two layers, covers the marble. The layer in contact with marble is 30-60 μm thick and brownish coloured, while the other one overlying it, is discontinuous, 40-50 μm thick, light-grey coloured, and externally darker with black airborne particles. Both layers contain red-orange particles (Fe silicates and Fe oxides). UV light images (not shown) reveal a whitish fluorescence in some areas of the patina and inside the grains of marble. Examinations of the thin section show that the stone is affected by inter and intra-crystalline micro-fractures and that the layer in contact with the stone penetrates marble’s micro-fractures. FTIR and EDS analyses enabled to differentiate materials of the external layer of the patina from the ones of the inner layer. Amide I and amide II bands, featuring protein substances, and phosphorus were detected on a brown material, perhaps belonging to the layer in contact with the stone. Moreover, oxalates were specifically identified in the external layer of the patina. Phosphorous and proteins may be associated to the treatment with casein used as binding medium, as reported in the literature (C. Gnudi, R. Rossi Manaresi, O. Nonfarmale, 1979) (R. Rossi Manaresi, 1973).

Fig. 3. Cross-section of a sample taken in the 1970s from the statue of St. Ambrogio (main portal).

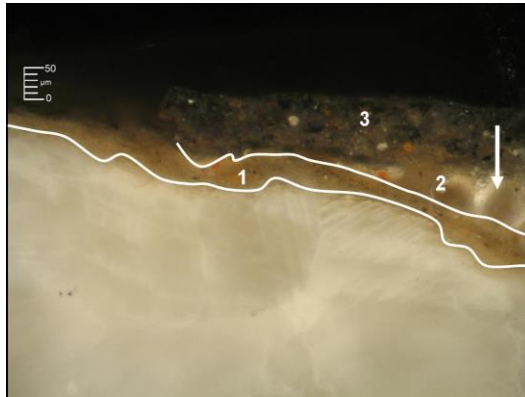
The cross-section of a fragment collected from the same statue in 2010 is shown in Fig. 4. Despite this sample comes from a different area, a comparison between the two samples can still provide insights into the changes occurred since the previous investigation. The marble, again micro-fractured, is covered by a compact, light brown patina 30 μm thick (labelled 1 in Fig. 4).

Fig. 4. Cross-section of a sample taken in 2010 from the statue of St. Ambrogio: 1- light brown patina (30 μm), 2- non-colored layer with gypsum, siloxane and acrylic resin (some glass spheres are visible on the right), 3- top black layer.

Combining ESEM-EDS and FTIR results, gypsum, aluminosilicates, a small amount of phosphorus and oxalates were detected in the patina. The non-colored layer over the patina (labelled 2 in Fig. 4) contains instead gypsum, siloxane and acrylic resin. Acrylic resin was identified by IR bands at 1730, 1480 and 1380 cm^{-1} , and siloxane by IR bands at 1274, 850 and 780 cm^{-1} . Other bands, which according to Favaro et al., (A.E. Charola, A. Tucci, and R.J. Koestler, 1986) are useful to evaluate the degree of degradation of the polymer mixture, are hidden by gypsum and silicates vibrations, and analyses of the extracts are still in progress. Nevertheless, the well detectable 1274 cm^{-1} band, assigned to the Si-C stretching of the group Si-CH₃, indicates that un-reacted alkoxy groups are still present in the polymeric mixture.

The top black layer contains mainly round-shaped carbon particles, gypsum and silicate, likely a deposit of airborne material. Furthermore glass spheres, 50 μm in

diameter, are present under the black external layer (Fig. 4). They are an evidence of the mechanical cleaning carried out with air-abrasive during the 1970s restoration.

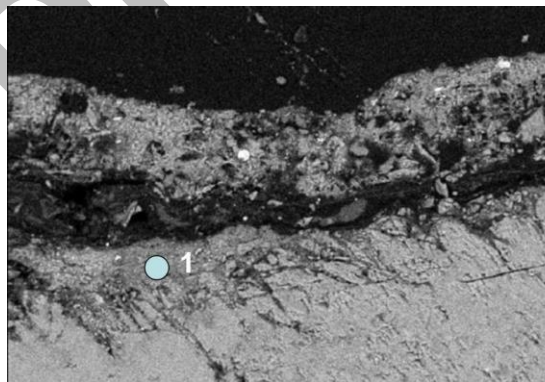
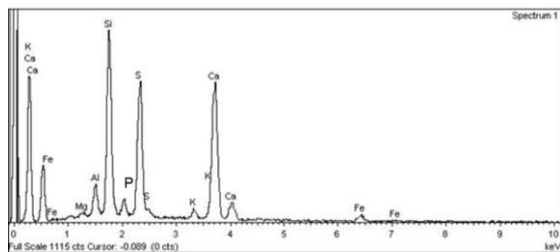
It is not continuous even though, when present, it looks adhering very well to the stone and partly penetrating the inter grain fissures (Fig. 5).

Fig. 5. Back- scattered electron micrograph of a detail of the cross-section of in Fig. 4. The compact, well adhering patina is visible. The EDS spectrum shows Ca, Si, S, Fe, Al, Mg, K and P.

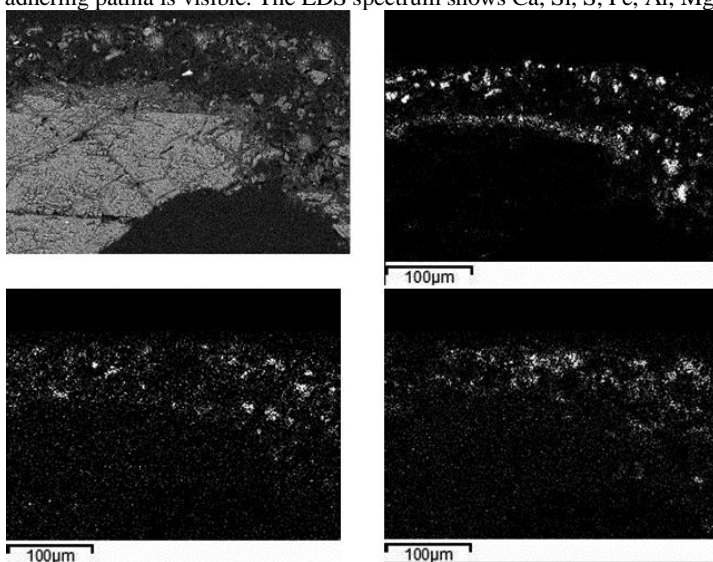
Fig. 6. Back- scattered electron micrograph of the cross-section of a sample from the Madonna statue (main portal). EDS maps of Si (top right), Al and S (bottom left and right).

On the statue of the Madonna on the main portal, the marble is covered by a mono-layered grey-brownish coloured patina (40-50 μm), containing orange and black particles, visible both in the 1970s sample and in the one of the 2010. Combining ESEM-EDS and FTIR results, gypsum, alumino-silicates, Fe oxides, phosphorus and oxalates were detected in the patina. The composition is similar to that of the previously discussed samples. The 2010 sample contained also siloxane and acrylic resin. A dark powdered atmospheric deposit with inhomogeneous thickness is visible on the patina. In both samples the marble is highly weathered but not affected by gypsum formation in between the grains. While gypsum occurs mainly inside the black deposit, silicon is instead layered into the patina as siloxane (see EDS maps of Si, Al and S in Fig. 6) and also dispersed in the deposit as silicate particles. Fig. 7 shows an ESEM picture of the patina's surface, where some flat areas composed of acrylic resin and siloxane are visible. They are covered by acicular and tabular (to a less extent) gypsum crystals and alumino-silicates aggregates. The coating covering the marble is still quite uniform and its appearance is similar to a newly treated surface (A.E. Charola, A. Tucci, and R.J. Koestler, 1986). It is worth mentioning that the whole depth of the superficial layer (patina + deposit) in both samples, is less than 150 μm and that the morphology of the cross-section is quite the same even after many years and an extensive conservation work. It seems that the marble has not undergone a further decay since the 1970s.

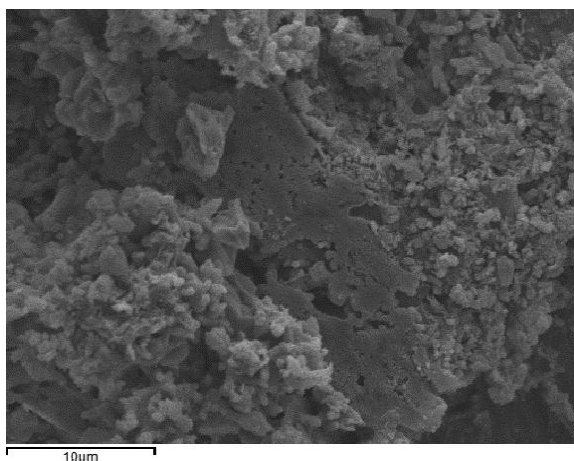
Fig. 7. ESEM micrograph of the surface of a sample from the Madonna statue. The polymer coating and acicular and tabular gypsum crystals are shown.

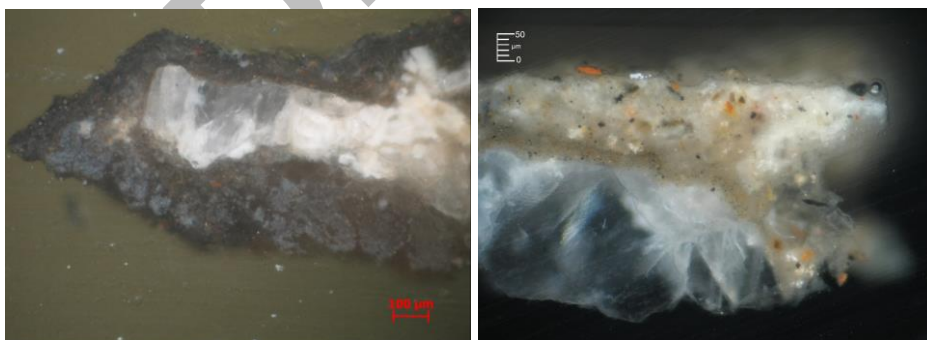
Carrara marble panels of the side portals are much more jutting out than the statues which are protected by the lunettes. Two samples from the panels of the right portal have been compared. The investigations carried out in the 1970s on samples' cross-sections showed two layers (more rarely three) over the stone. This result is observable in the cross-sections of a sample taken in the 1970s from the panel depicting “the Coronation of the Virgin” (Fig. 8) and of a sample taken in 2010 from the panel depicting “The Flagellation of Christ” (Fig. 9). In both of them, over the micro-fractured stone, a two-layered patina is visible, where the layer in contact with marble is thin (10-20 μm), compact, brown coloured and partially penetrating the marble micro-fractures.

Fig. 8 (left) Cross-section of a sample taken in the 1970s from the panel depicting “the Coronation of the Virgin” (right portal).

Fig. 9. (right) Cross-section of a sample taken in 2010 from the panel depicting “The Flagellation of Christ” (right portal).

Over the layer in contact with stone, a thicker (from 70 to 100 μm in both samples) grey coloured one is visible. Despite the fact the elemental composition (Ca, S, Si, Al, Fe) of both layers is the same, the external one contains a larger number of orange, white and black particles.

The grey layer of the 1970s sample goes under the stone fragment just like if it had entered fractures of the stone, favouring the detachment of little scales. It is covered by a black deposit.

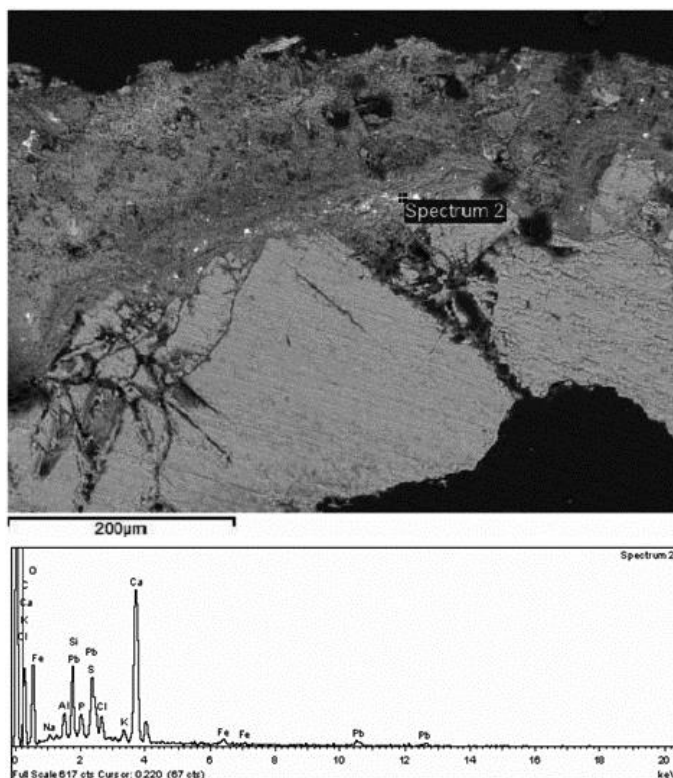
Combining ESEM-EDS and FTIR results, gypsum, aluminosilicates, Fe oxides, traces of oxalates and a natural wax (identified by the bands at 1730 cm^{-1} , $\sim 1465\text{ cm}^{-1}$ and $\sim 1053\text{ cm}^{-1}$) were detected in the layer in contact with marble. The 2010 sample contained also siloxane and acrylic resin. Micro-FTIR with ATR on thin-section of the older sample reveals, along with silicates signals, bands at ~ 1540 and 1504 cm^{-1} assigned to carboxylates. These last results are likely an evidence of altered oil or wax. The 2010 sample also contained lead and phosphorous, both detected by EDS (Fig. 10).

The EDS map of the 2010 sample shows that gypsum is mainly located on the outmost surface. It is probably connected to dry deposition along with black particles also observed. The results obtained on samples from the side portals do not fully match those of the 1970s research reporting a mono-layered patina and in particular the lack of the beeswax protective coating detected instead on the main portal. On the contrary our examinations of old and recent samples from the side portals clearly show a thin, organic-based treatment, which preserved the underlying marble over time. Lead detected in the sample from "The Flagellation of Christ" could be related to a remnant of a "scialbatura" layer.

Fig.10. Back- scattered electron micrograph of a detail of the cross-section in fig.9. EDS spectrum of a spot where Pb was detected.
