**ULTRASONIC VELOCITY MEASUREMENTS FOR THE LONG-TERM  
MONITORING OF THE DEGRADATION OF MARBLE COLUMNS IN THE  
CLOISTER OF THE CHURCH OF SAINT-TROPHIME IN ARLES (FRANCE)**

Philippe Bromblet<sup>1</sup>, Véronique Vergès-Belmin<sup>2</sup> and Stefan Simon<sup>3</sup>

**12th International Congress on the Deterioration and Conservation of Stone  
Columbia University, New York, 2012**

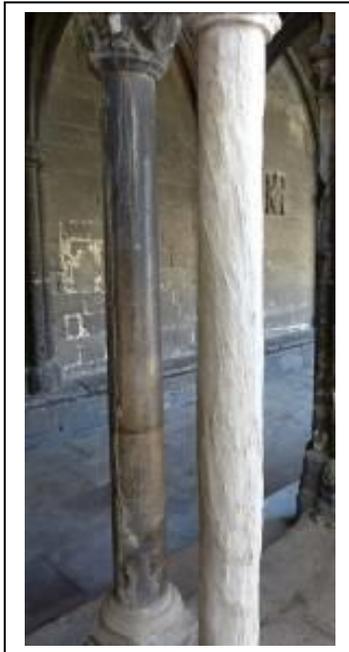
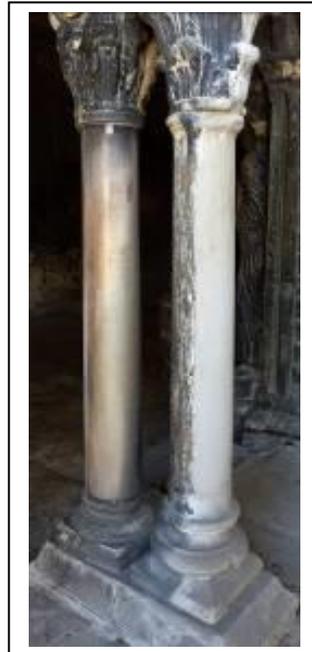
**Figure 1.** Limewash application on external faces of columns 94 (on the left) and 74 (on the right).

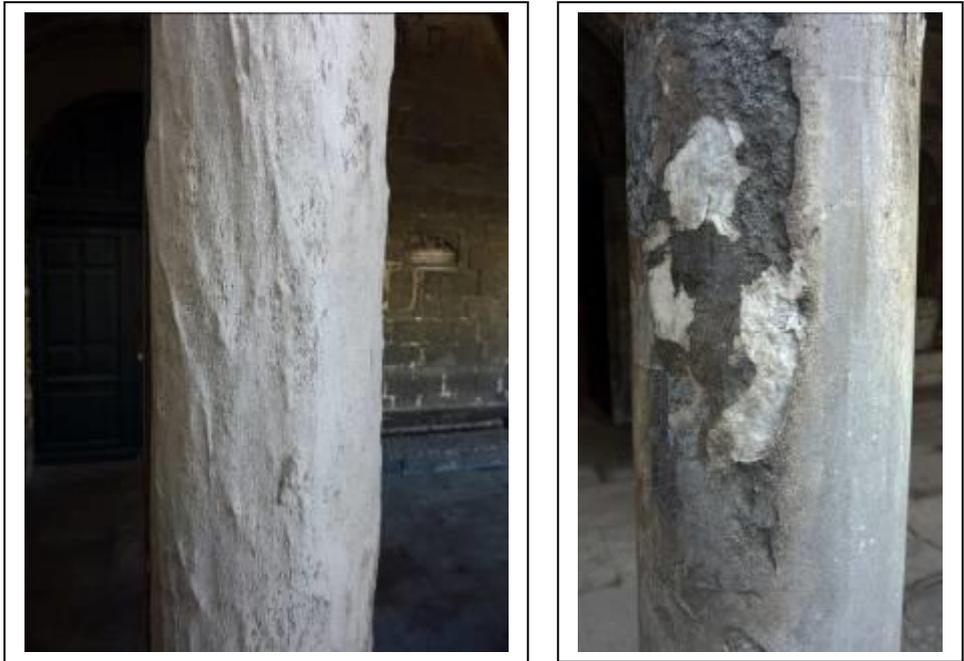
**Figure 2.** Granular disintegration pattern underneath sacrificial limewash (column 94, on the left side) and contour scaling (column 15 on the right side). Facings put on the scaling area have been removed in 2010 (photo 2010).

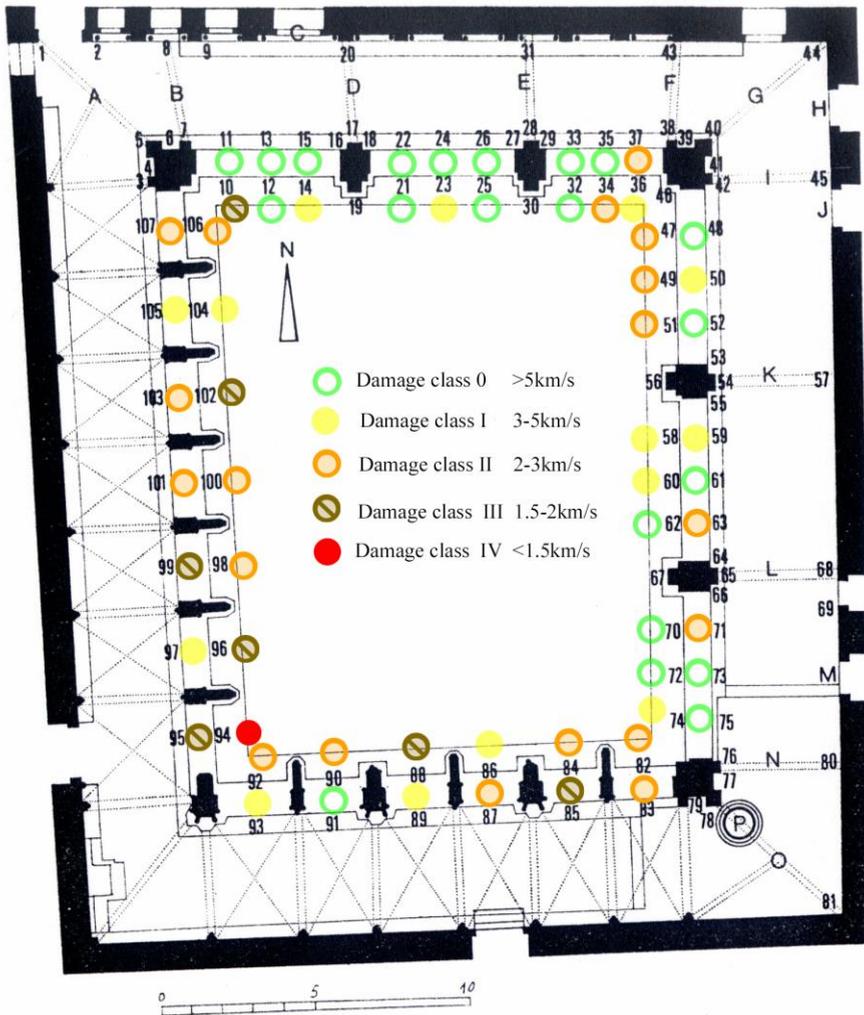
The average velocities ranged from 800 to 6100 m/s and the columns were classified into 5 damage classes from complete structural deterioration (class IV  $\leq 1500$ m/s) to unweathered marble (class 0  $> 5000$ m/s) according to a slightly modified version of velocity–porosity correlation of Köhler (1991 in Ahmad *et al.* 2009). No significant difference was put in evidence between measurements realised at the bottom or at the top of the columns. No difference also appeared for the measurements performed parallel and perpendicularly to the gallery. The velocities described a very complex picture of the preservation conditions (Fig.3). Nevertheless the lowest values were measured on the columns of the west gallery which is the youngest one, with an

average velocity of 2500m/s and on those of the southern gothic gallery (3090m/s). The columns of the oldest north gallery were in the best state of conservation with an average velocity of 4800m/s and the columns of the Romanesque east gallery were also in a rather good general condition with an average velocity of 4340 m/s. The five columns (61, 70, 72, 73, 75) replaced in the east gallery during 1841 restoration work were in very good state (damage class 0). Some columns without evidence for any replacement showed also very high velocity higher than 5000m/s. A few columns (11, 22, 26, 91) with ultrasonic velocity higher than 6000 m/s might be dolomite marble. In general, velocity was higher on interior and more sheltered than exterior and more exposed columns (average velocity 4210 vs 3430m/s). The smaller the surface covered by direct water run-off or percolation traces is, the higher the ultrasonic velocity (Simon *et al.* 1994).

**Figure 3.** Mapping of the different classes of damage attributed to the 62 columns of the cloister in 1993 (Simon *et al.*, 1994).

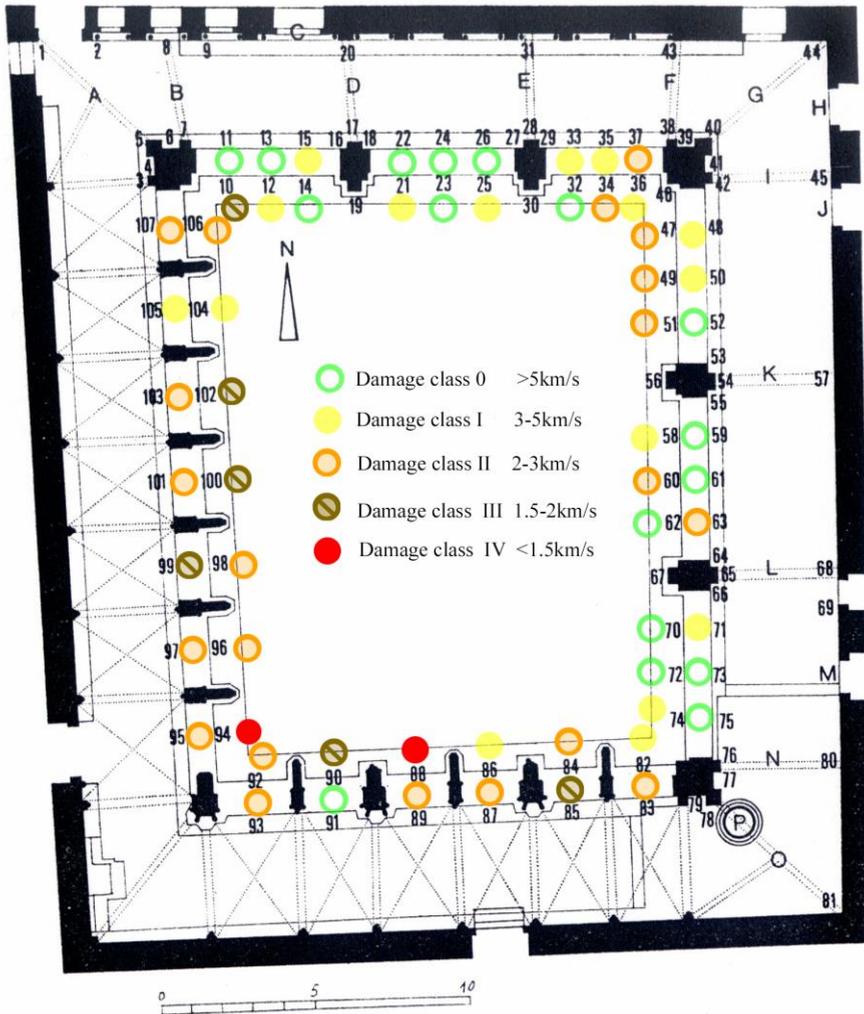
**Figure 4.** Mapping of the different classes of damage attributed to the 62 columns of the cloister from the ultrasonic velocities measured in 2009

The ultrasonic velocities ranged from 650m/s to 7100m/s (Fig.4). Damage class 0, meaning no damage, still characterized the columns 61, 70, 72, 73, 75 replaced in 1841/42 in the eastern gallery. The highest average velocity was still measured on the columns of the oldest northern gallery (4715m/s) and afterwards on the ones of the east gallery (4500m/s). The younger galleries still showed weaker materials; the average value of the southern gallery was 2770m/s and the lowest average velocity remained for the youngest western gallery (2370 m/s). Velocity was still higher on interior and more sheltered than exterior and more exposed columns (average velocity 4100 vs 3390m/s).

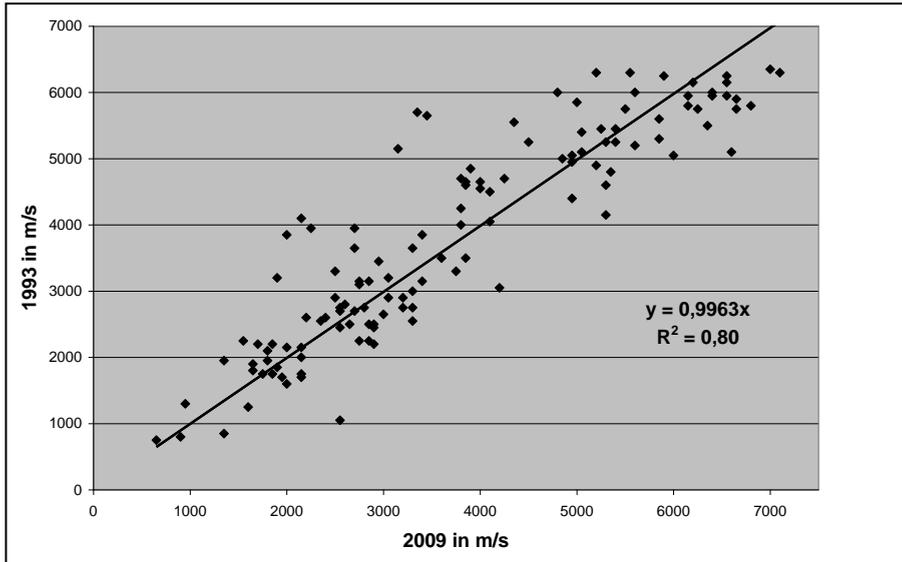
The velocities measured in 1993 and 2009 on the columns are significantly correlated (Fig.5). The comparison between the 2 campaigns is relevant in spite of the difference of equipment and frequency. The fact that the correlation is not very good (regression coefficient 0.80) indicates an evolution of these velocities during this period.

Figure 5. Correlation curve of 1993 measurements vs 2009 measurements for the 62 columns.

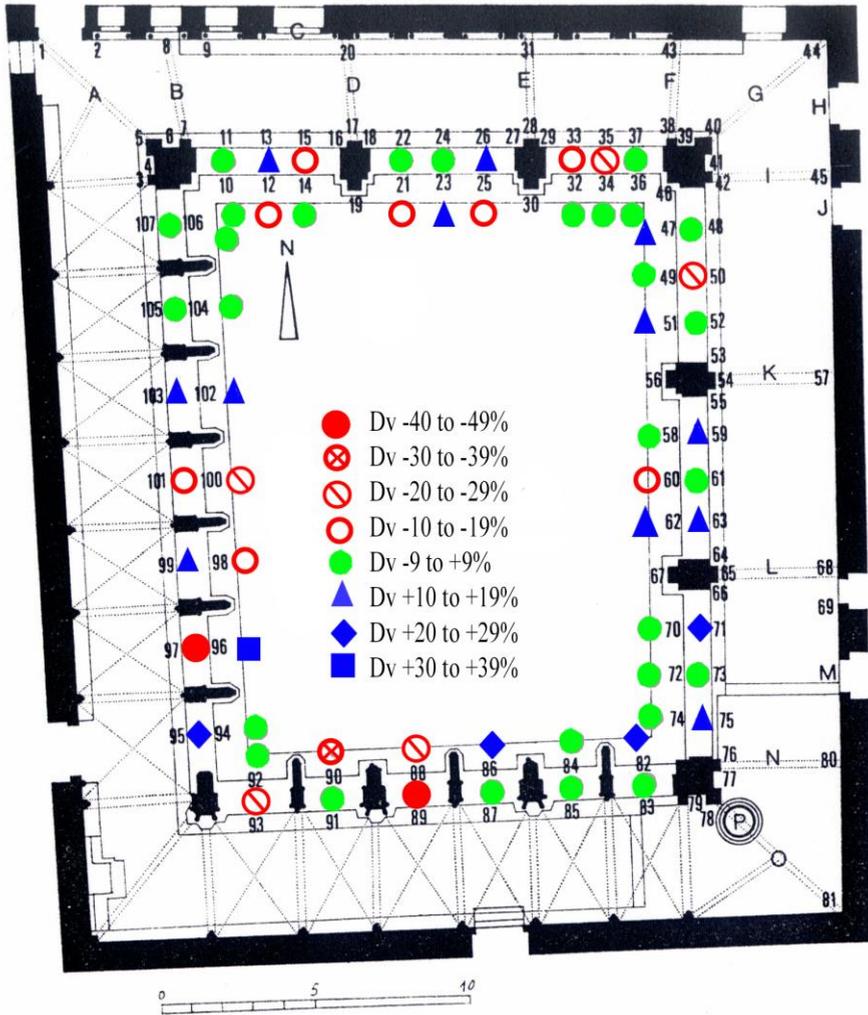
In fact, the calculation of the difference of ultrasonic velocity  $Dv = (V_{2009} - V_{1993}) * 100 / V_{1993}$  provides more detailed information on the evolution of the columns.  $Dv$  varies between - 49% up to +39% (Tab.4). From 1993 to 2009, 16/62 columns show a velocity reduction of more than 10%. 8/15 of these columns are located in the south-west corner of the cloister in internal as well as external location (Fig.6). Among them, intern columns 89 and 97 show the worst evolution with a  $Dv$  between -40 and -49%. Extern column 90 has lost -36% of its velocity. Five other ones (35, 50, 88, 93 and 100) have lost between -20 and -29% and height (12, 15, 21, 25, 33, 60, 98, 101) only -10 to -19%. Twenty nine columns have not been significantly affected by any change, among them the 5 columns placed during Renaux's restoration in 1841/42. The expected drying of marble due to significant improvements of the water collection system in the cloister may account for a limited decrease of the ultrasonic velocity of many columns. As a matter of fact, it is known that ultrasonic velocity is higher on wet stones than on dry

ones (Weiss *et al.* 2002; Ahmad *et al.* 2009). Nevertheless this drying cannot explain alone the huge reduction of velocity which points out a worsening of the state of conservation of several columns 16 years after the first campaign of ultrasonic measurements.

**Figure 6.** Mapping of 8 classes of difference of ultrasonic velocity (Dv) between 2009 and 1993 for the 62 columns of the cloister.

Ultrasonic velocity of seventeen columns has increased in the range +10% - +34%. These columns belong to the damage classes 0, I, II and III. The phenomenon concerns 7 intern or extern columns of the east gallery, 5 from the west one, 3 from north and 2 from south (Fig.6). This increase is not specifically linked to the application of the

sacrificial limewash or the application of facings on scaling parts of the columns (Tab.4) after the 1993 campaign. The ultrasonic devices working respectively at 54 (2009) and 250kHz (1993) have investigated the internal disintegration (microcracking) of marble and not at all the superficial hardening or protective effect of restoration interventions carried out after 1993. In their review, Ahmad *et al.* (2009) pointed out that investigations on the effect of these surface treatments as well as superficial degradation processes required much higher transmitter frequencies (>2000kHz). The evolution toward a higher ultrasonic velocity can not be linked to any water content increase. It should be interpreted as an improvement of the material condition and could result from the reduction of water content within the masonry since 2003/2004 restoration work which intended to reduce rising damp, rainwater run-off and percolation from the terraces. The drying phase induced by this work may have had many consequences on the marble properties for the most exposed columns to water, e.g. a partial filling of pores due to calcite and soluble salts crystallization or an increase of mechanical strength. Closure of microcracks consecutively to modification of loading of the columns after restoration work in the upper part of the building (terraces) is also possible. Study of marble samples and laboratory experiments would be necessary for a deep understanding of the cause of this increasing of velocity.

In conclusion, this monitoring performed almost over two decades emphasizes the need to improve the conservation state of the columns and justifies both the work undertaken in 2003/2004 to manage the water drainage and the restoration work started
