LINOSTONE: A SANDSTONE COATING PRODUCT INVESTIGATED

A. B. Custance-Baker¹

Abstract

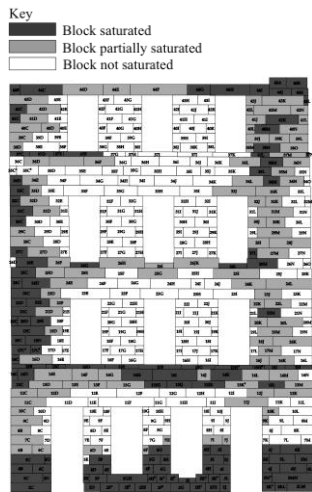
Fig. 1. Water dispersal issues

During heavy rainfall, prior to erection of the scaffolding, the case-study building showed four main areas of enhanced water saturation; a point at the right-hand side of the gutter directly below the chimney where water appeared to be directed toward the wrong end of the gutter and was subsequently overflowing and draining down the front of the building; a point half-way down the left-hand side of the façade beside the down pipe and adjacent bay window ledge; the two string courses between the ground and first floors; and a significant rising damp issue at ground floor level. This data was not collected as part of the block-by-block surveys and could therefore not be accurately correlated with the other data sets from which block diagrams were produced, but a diagram was produced to represent the observations.

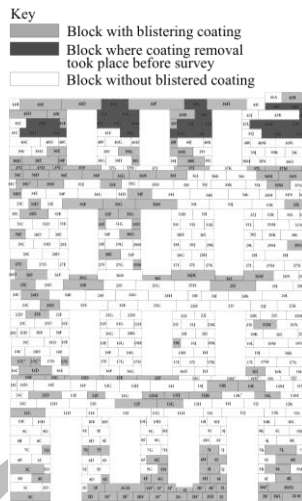
Fig. 2. Blistering coating

In several places on the case study building the coating had a blistered appearance. The blisters varied from tens of centimetres in diameter down to less than one millimetre. If a small amount of pressure was applied, the majority of the blisters could be broken in a brittle manner revealing a cavity behind, either hollow or containing loose sand grains derived from the stone substrate. Coating material that had detached from the stone substrate was commonly observed to have several millimetres of sandstone still attached to its inner surface. The block diagrams for blistered coating and the observations of water saturation were compared and indicated that blistering is more likely to occur in a water saturated area.

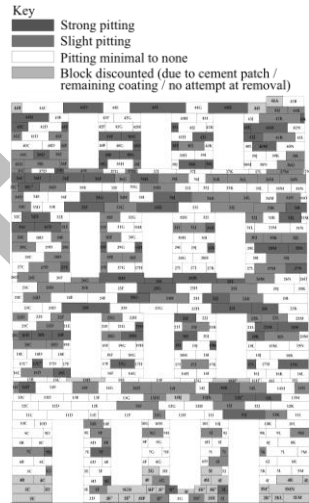
Fig. 3. Coating removal pitting

The apparent damage caused by the coating removal technique was recorded as; no pitting, minimal pitting, slight pitting and strong pitting. The blocks that might require replacement as a result of damage following coating removal were identified as 'slightly pitted' and those identified as 'strongly pitted' were considered to almost certainly require replacement. Sandstone in close proximity to a cement patch seemed to have a high chance of suffering from severe pitting.

470 blocks of stone were surveyed following removal of the coating and of these 243 were recorded as having no pitting or minimal pitting, 110 with slight pitting and 84 with strong pitting. 33 blocks were not assessed because either a cement patch was covering the entire block or no attempt had been made at removal because it was already clear that the stone would need replacing.

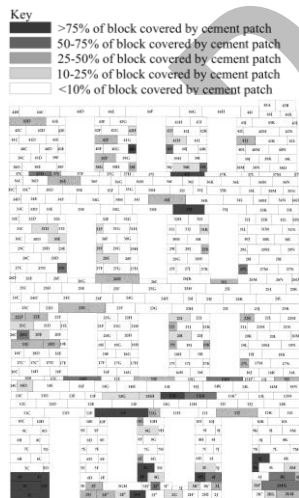
Fig. 4. Cement patches

The block diagram for cement shows just the locations of cement patches covering more than ten *per cent* of a block's surface, but does not display the widespread use of cement along the joints (generally less than ten *per cent*). The notable areas of cement patching on the case-study building include a cluster at the first floor level on the left-hand side and at the base of the building; both areas identified as having high levels of water saturation following heavy rainfall.

Almost 20 *per cent* of the masonry blocks on the case-study building had a cement patch covering at least ten *per cent* of the surface area. One third of these were located on rows two to six at ground floor level (row one was not documented). Just over a quarter (27 *per cent*) of the masonry blocks adjacent to a window or door were found to have a cement patch covering more than ten *per cent* of the surface area. Only 13 *per cent* of blocks not adjacent to an opening were found to have a similar cement patch.

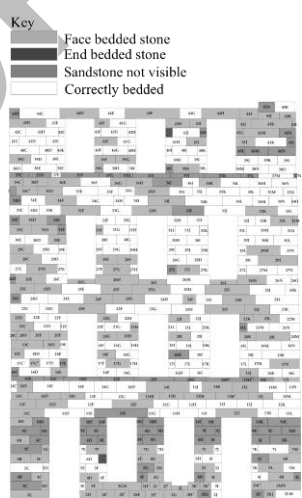
Fig. 5. Natural bedding direction

should be placed with the bedding planes horizontal. However, sandstone can often be found with the bedding planes vertical and either parallel with the outer face of the building, face bedded, or perpendicular to the outer face of the building, end bedded. These stones are inherently weaker within a structure. From here on face bedded and end bedded stones, will be referred to collectively as 'incorrectly bedded', which applies to more than 40 *per cent* of the blocks. It was not possible to assess this where the coating had not been removed, where there was a large cement patch or where a dark pollution layer obscured the stone's surface; this was the case for 84 of the 470 masonry blocks. The main indicator of incorrectly bedded stones was the presence of the platy mineral mica lying parallel with the surface of the stone.

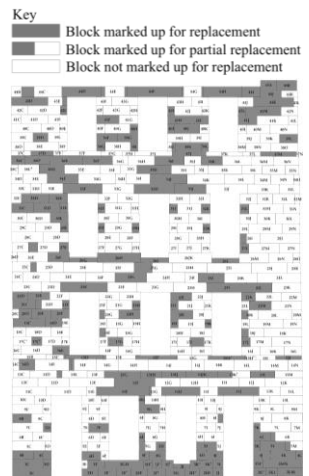
Fig. 6. Stone replacements

One third (32.5 *per cent*) of the total blocks on the case study building were marked up for full replacement and a further six *per cent* for partial replacement. Many of these partial replacements were intended to be replaced with a neighbouring stone enabling replacement as a single block. Ten of the 13 lintels on the case study building were marked up for replacement. Of these, nine were found to be face bedded; the three lintels not requiring replacement were all correctly bedded.

Following removal of the coating, the project architect marked up the masonry blocks that would be requiring replacement, as displayed on the block diagram. Not all of the damaged blocks were to be fully replaced, but where possible, if the damage was localised at an edge beside a stone being replaced, then this could be replaced as one.

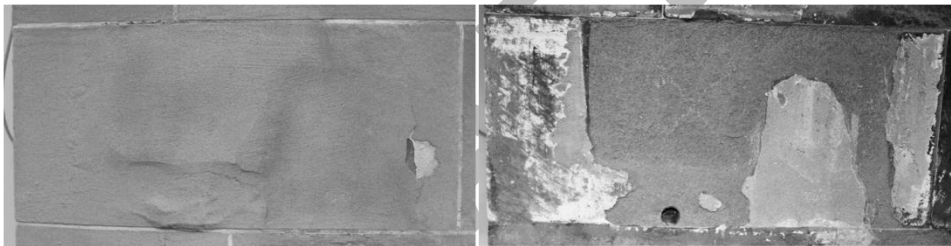
Most cement patches did not cover the entire block and observations tended to show that the coating blistered over the sandstone at the margins of the cement patches rather than overlying the cement (see figure 7).

Figure 7: The same block on the case study building that showed blistering of the coating prior to removal (left) and cement patches either side of the area of blistering coating following its removal (right). A stone core was taken from the block, visible at the base of the right-hand image.

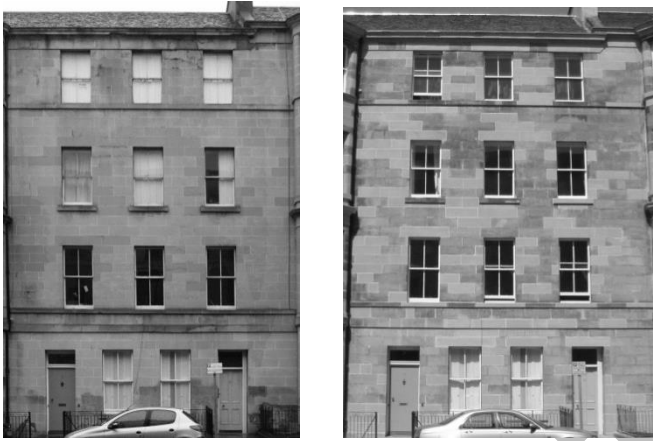
Figures 8. & 9. The case study building prior to any work being carried out in 2008 (left) and following completion of the work in 2009 (right).
