INVESTIGATION OF THE DEGRADATION PHENOMENA OF THE LUXEMBOURG
SANDSTONE IN THE ROYAL MUSEUM FOR CENTRAL AFRICA (BELGIUM)

Hilde De Clercq,¹ Laurent Fontaine,¹ Sebastiaan Godts,¹ Roald Hayen,¹ Michiel Dusar²
and Marleen De Ceukelaire²

**12th International Congress on the Deterioration and Conservation of Stone
Columbia University, New York, 2012**

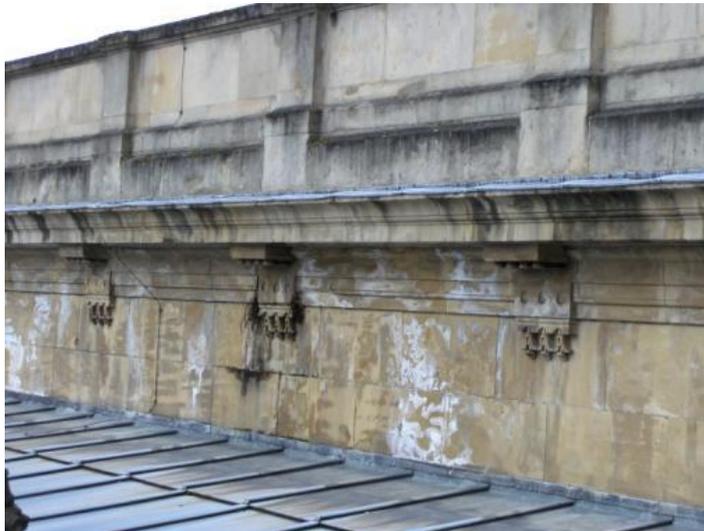
network caused large amounts of water to infiltrate in the walls during long periods. This caused important damage to the sandstone blocks with crack-formation, scaling, spalling and (salt) staining as a result (Figures 2 and 3).

Figure 2. (Salt) staining underneath the cornice where the water evacuation system is hidden behind the wall. Two varieties of the Luxembourg sandstone can be seen: a warm yellow coloured variety below the cornice and a light grayish one above it.

The stones directly under the cornice (Figure 2) display at several locations scaling and large areas of gypsum efflorescences. In the outer cm of the Luxembourg sandstone a gypsum content of up to 6 wt% and more rare amounts of nitrates allied to potassium are measured. A systematic correlation between the intensity of gypsum efflorescence, the gypsum content in the stone and the observed damage could not be found. Figure 6 illustrates where gypsum is intensively deposited at the surface following water infiltrations in the wall, while the salt load measured in the stone is almost zero.

Salt extraction is futile due to the low solubility of gypsum. It is expected that proper maintenance interventions to stop further water infiltration will prevent the continuation of the deterioration processes.

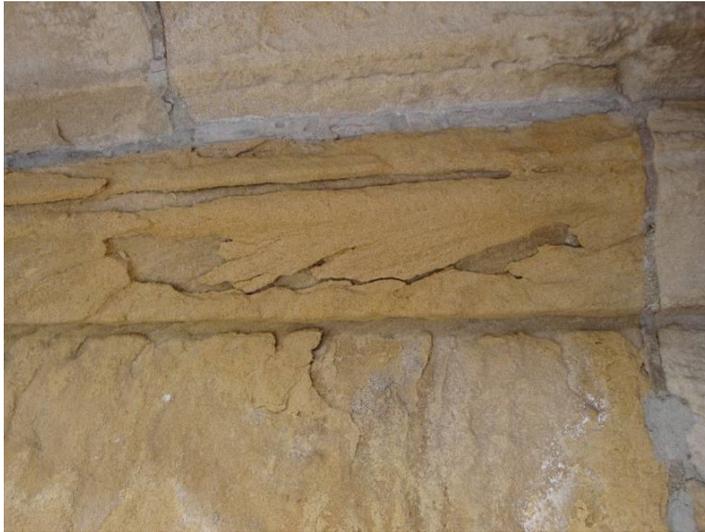
Figure 3. Scaling of the calcareous sandstone blocks underneath the cornice.

In some cases, as presented in Figure 3, severe scaling is observed while almost no salts are detected in the stone. Supposedly micro-cracks were formed that are a result of the transformation of lime into gypsum and the migration of gypsum to the lower parts of the wall, being transported by the high water load. Once micro-cracks are formed damage caused by freeze-thaw cycles cannot be excluded, despite the fact that the Luxembourg sandstone is considered frost-resistant (Dusar et al 2009).

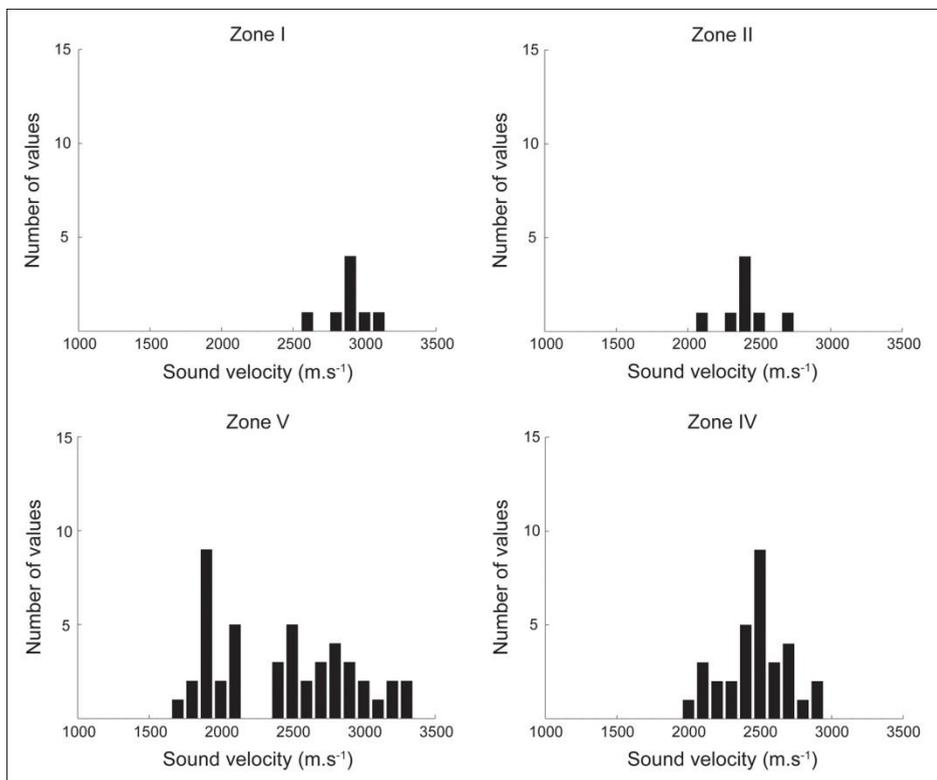
The principle of ultrasound velocity measurements is based on the determination of the velocity at which a sound wave passes through a sample of known size. The results are indicative for the assessment of the quality of a stone material in terms of cohesion, porosity and homogeneity. The overall results from the in situ measurements on 28 corner blocks, 67 dentils and 30 balusters revealed a sound velocity varying from 2018 to 2944 m.s⁻¹. Figure 4 illustrates some results obtained for both varieties (calcareous sandstone and pure sandstone). The graphs show how the results of the ultrasound velocity measurements are partly superimposed and thus are not suitable to identify the stone varieties or to characterize the architectural elements. However, from the measurements on the dentil profile (Figure 5) the presence of internal cracks can be derived from the ultrasound velocity. Values lower than 2000 m.s⁻¹ are considered an indicator for internal damage being already present.

Figure 4. Results of ultrasound velocity measurements (m.s⁻¹) of stone corner blocks (variety calcareous sandstone, zones I (top left) and II (top right)), dentils (variety calcareous sandstone, zone V, bottom left) and balusters (variety pure sandstone, zone IV, bottom right).

The state of conservation of the individual stone blocks, containing between 6 and 12 sculpted dentils, was assessed and criteria were defined based on the results of the ultrasound velocity measurements to assess the risk for any future damage. From the analysis of the results obtained on stone blocks with already missing dentils or where internal damage could be assessed based on the ultrasound measurements, ultrasound velocities above 2800 m.s^{-1} are considered sufficient for the stone blocks to be in a sound condition and that future damage is unlikely. From these findings it is concluded that only about 10 % of the sculpted stones are not in danger of exhibiting damage in the future. The seemingly random breaking off of the dentils can be explained by high amounts of salty water infiltration, possibly engraved by the mechanical forces exerted while sculpturing the dentil profiles, and which resulted in the formation of internal micro-cracks.

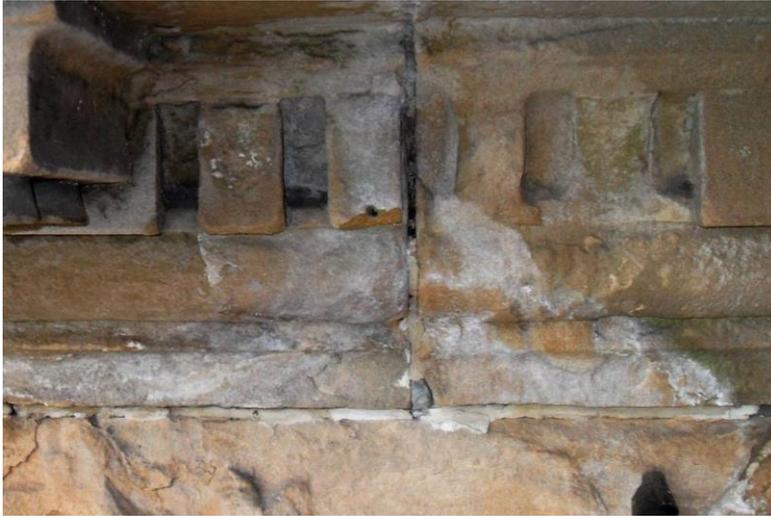
Figure 5. Zone below the cornice showing extensive efflorescence of gypsum and loss of some dentils. The outer cm of the stone contains gypsum (2 wt%, further decreasing with depth).

Apart from the damaged dentils, which have already broken off at their rear end, superficial flaking and extensive efflorescence of gypsum can be observed in some areas. Quantitative salt measurements proved that the outer centimeter of the dentil profile contains locally up to 2.2 wt% of gypsum, decreasing with depth. Generally, gypsum is not considered the cause for the damage because of its low solubility and migration properties (Charola et al 2007). However, it cannot be excluded that, due to the high quantity of water infiltrations, gypsum might play a role in the general deterioration phenomenon as an initiator of microfissuration.

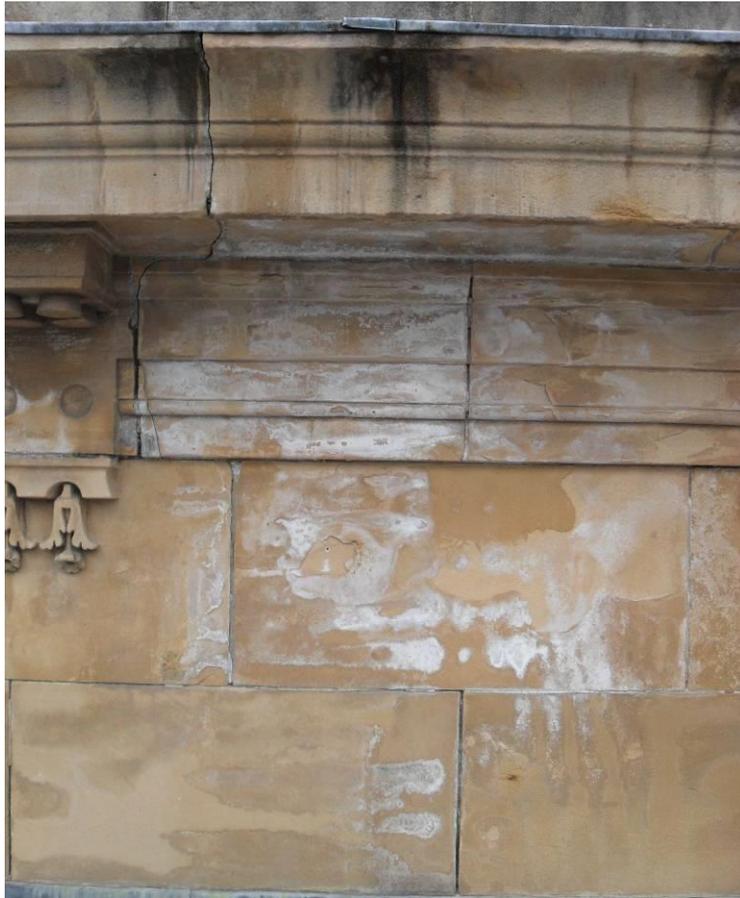
Figure 6. A high amount of gypsum efflorescence is seen, while scarce amounts of salts are detected in the underlying stone.

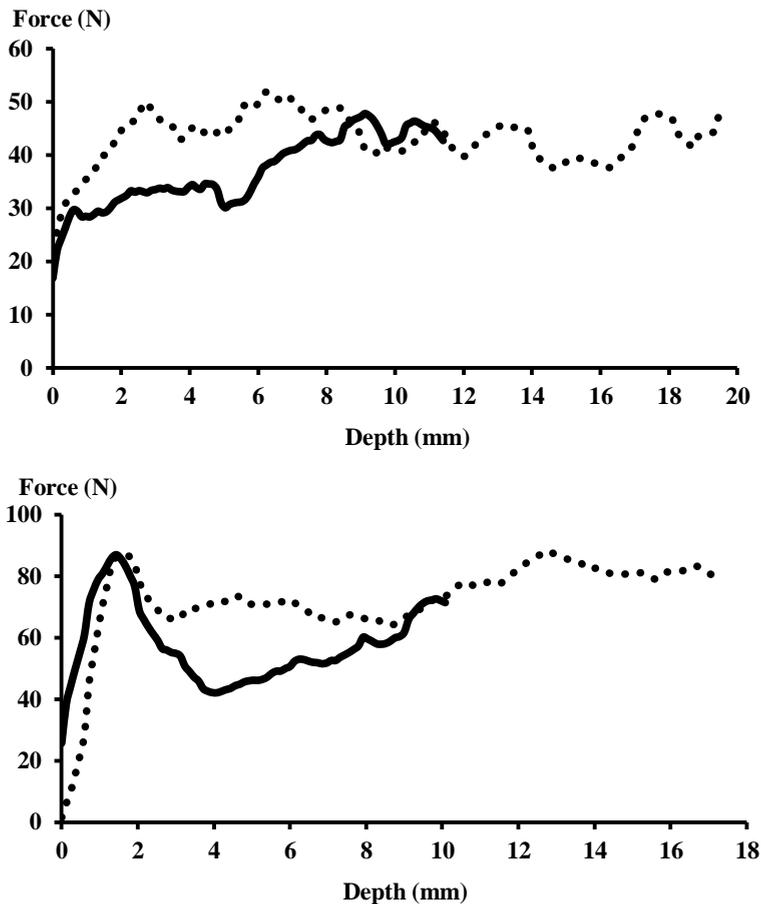
Hardness profiles obtained by the DRMS device show that the global conservation state of the Luxembourg sandstone is good. Surface weathering generally ranges from 3 to 7 mm depth and reaches exceptionally a depth of 11 mm. A rather positive consolidation effect was obtained after three applications with a 100% product of TEOS (Figure 7, upper part). After the treatment a higher mechanical resistance of the weathered areas is measured at certain locations when compared to the underlying stone material.

Figure 7. Hardness profiles of Luxembourg sandstone characterized by a weathered zone of 7 mm (upper part) and by a calcinated layer of a few millimeter depth (lower part) before (solid line) and after (dotted line) 3 applications with a 100% solution of TEOS.

The carbonate content in the Luxembourg sandstone is between 15 to 34% (Dusar et al 2009) and results locally in the formation of a so called calcinated layer or hard superficial millimetric layer, which is formed after the construction of the building. Underneath this layer a somewhat weathered layer is noticed. The consolidation using

TEOS insufficiently improved the mechanical properties of the weathered area underneath the dense outer layer (Figure 7, lower part).

Hence, it was finally recommended to opt for two applications of the product, which corresponds to a consumption of approximately 2 l.m^{-2} .
