**MULTIDISCIPLINARY CHARACTERIZATION OF GYPSUM CRUST ON
LEDE STONE (BELGIUM)**

Tim De Kock^{1,4,a}, Jan Dewanckele^{1,4}, Marijn Boone^{1,4}, Laszlo Vincze², Gilles Fronteau³,
Luc Van Hoorebeke^{4,5}, Patric Jacobs^{1,4} and Veerle Cnudde^{1,4}

**12th International Congress on the Deterioration and Conservation of Stone
Columbia University, New York, 2012**

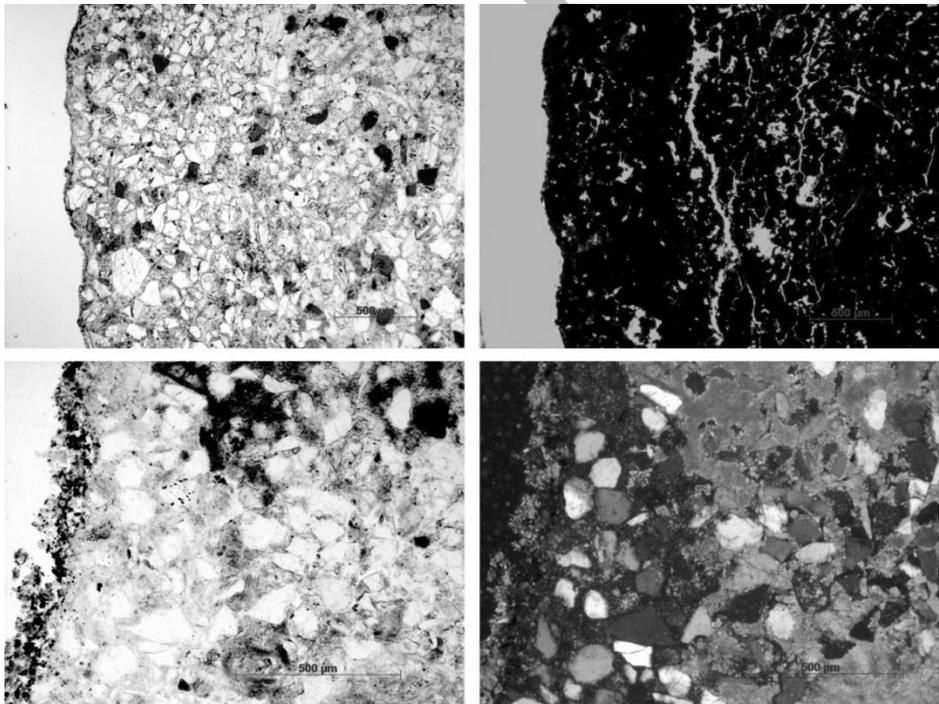
Thin sections of the sample reveal the typical structure of a black crust as shown in Figure 1. A superficial black layer can be observed. It is very thin, approximately 10 µm thick, and consists of encrusted material, such as a wind-blown very fine silt fraction and particulate matter, which colors it black. Below this superficial layer, there is a zone of chemical alteration with an average thickness of 50 µm. It consists of authigenic stone material with a progressive dissolution of carbonates and precipitation of gypsum (Figure 1), which is bordered by an alteration front. In detail, it can be observed that crystallization occurs at the quartz-sparite interface. In this way, quartz grains are detached from the sound stone and incorporated in the gypsum matrix, while the carbonate cement is progressively dissolved. Porcelaneous forams form a second nucleation site for gypsum precipitation. Their microporous wall seems to be susceptible for the in situ replacement of carbonates by gypsum.

Figure 1. Thin sections of the black crust. Top left black crust in plane polarized light. Top right: same section with the bulk given in black and porosity given in grey. One large and several small cracks are visible. Bottom left: zoom on the black crust in PPL. Three zones are distinguishable: a topmost black layer with encrusted material. Secondly, just below the topmost layer, a gypsum

alteration zone, with crystalline gypsum and detached stone patches or individual quartz grains. Below this second zone, the sound stone is visible. Bottom right: same section in XPL.

Cracks can be observed in the crust and below (Figure 1, top right). Small cracks occur throughout the sample's surface. They penetrate the zone with gypsum alteration and continue into the sound stone. The cracks are sub-parallel orientated to the surface and follow grain boundaries. Infilling of these cracks by gypsum is not observed. Therefore no relation between crack formation and gypsum formation is suggested.

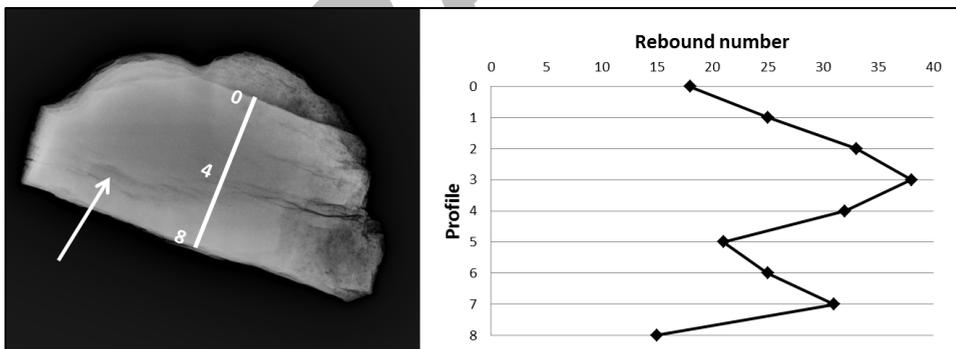
X-ray radiographs of the stone (Figure 2) indicate the presence of a major subhorizontal crack inside the stone. This crack became visible when the stone was cut into two equal parts. A Schmidt hammer profile was taken along the cutting plane, with a 10 mm interspace (Figure 2). The rebound numbers are a measure of the rocks hardness. Normally, the higher the rebound number, the higher a rock's hardness. As these measurements are correlated within one rock, the rebound number variation can be attributed to a degree of weathering, taking into account the natural heterogeneity of the stone. Indeed, on both top and bottom side just below the weathered surface, the rebound numbers are the lowest. Especially on the top, rebound numbers increase to the inside and are doubled 30 mm below the stone surface. A decrease in rebound number is obvious around the major crack seen on the radiograph. These rebound number thus show a decrease in rock strength towards the weathered surface, but also in the center of the stone, where a major crack has developed.

Figure 2. X-ray radiograph of entire stone revealing major cracks inside. The rebound number (Schmidt hammer) along the profile represents the relative rock's strength.

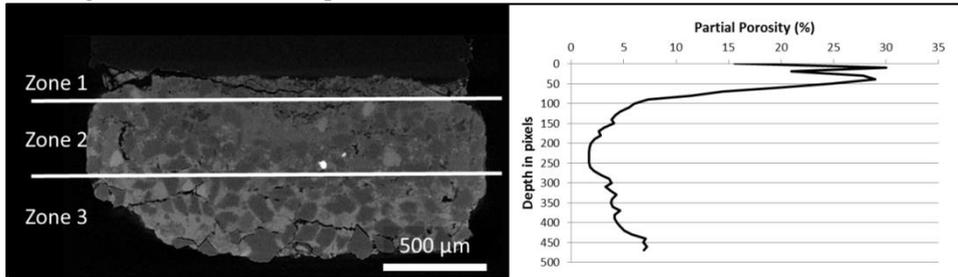
Subsamples of different sizes (\varnothing 10 mm, 3.4 mm & 1.8 mm) were drilled perpendicular to the weathered surface and subsequently analyzed with μ CT. The structure of the upper millimeter can be seen on Figure 3, where three zones can visually be distinguished: zone 1, 2 and 3. The topmost zone 1 of the crust contains small particles and a high porosity. Zone 2 has a lower porosity than zone 1 and based on their shape, quartz grains can be recognized. The intergranular space in this zone is filled with a matrix with low grey value (Figure 3). Zone 3 consists of similar quartz grains as zone 2, but the intergranular space is filled with a matrix with a relatively higher grey value

than zone 2 and some cracks are visible. These three zones might be recognized in a partial porosity profile, with zone 1 having the highest detectable porosity, zone 2 the lowest and zone 3 a porosity which correspond most to the sound stone's porosity with local higher values due to the presence of cracks (Table 1).

Figure 3. Reconstructed CT slice of the black crust. Three zones are distinguishable, with different porosity and grey values; the topmost layer with high porosity and very fine grained material (zone 1); a second layer with quartz grains (lowest grey value), calcite patches (high grey value) and a gypsum matrix (intermediate grey value) (zone 2) and a third layer with quartz grains and calcite cement of which the grey value is similar to the same material in zone 2 (zone 3). Cracks are clearly visible inside the stone, throughout the three zones.

Table 1. Average porosity of zones referred to in Figure 3.

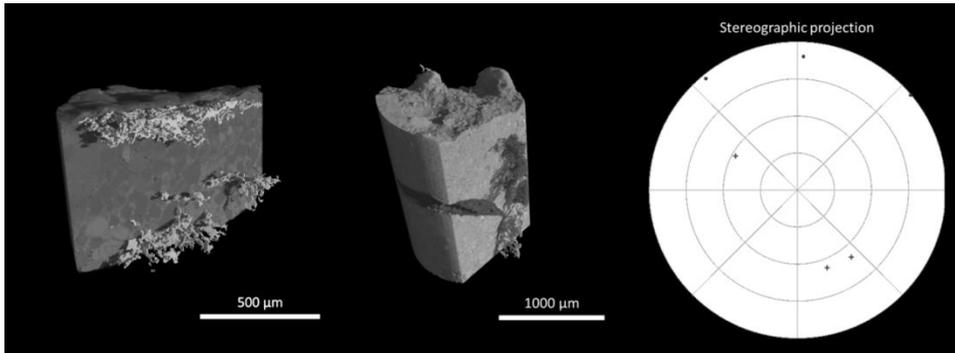
The orientation of the main cracks was calculated and visualized in a stereographic projection by their poles to planes according to Brabant *et al.* (2011) (Figure 4). The three cracks observed in the smallest sample, being less than two millimeters below the surface, plot almost horizontal. In essence, this means parallel to the surface. The cracks occurring in the bigger sample are deeper below the surface. These show a more inclined orientation towards the surface and penetrate deeper inside the stone.

Figure 4. Left: uppermost part of the crust with subhorizontal cracks. Center: Inclined cracks deeper inside of the stone. Right: stereographic projection according to Brabant *et al.* (2011). The dots represent a horizontal orientation of the uppermost cracks, the crosses indicate a more inclined orientation for the deeper cracks.

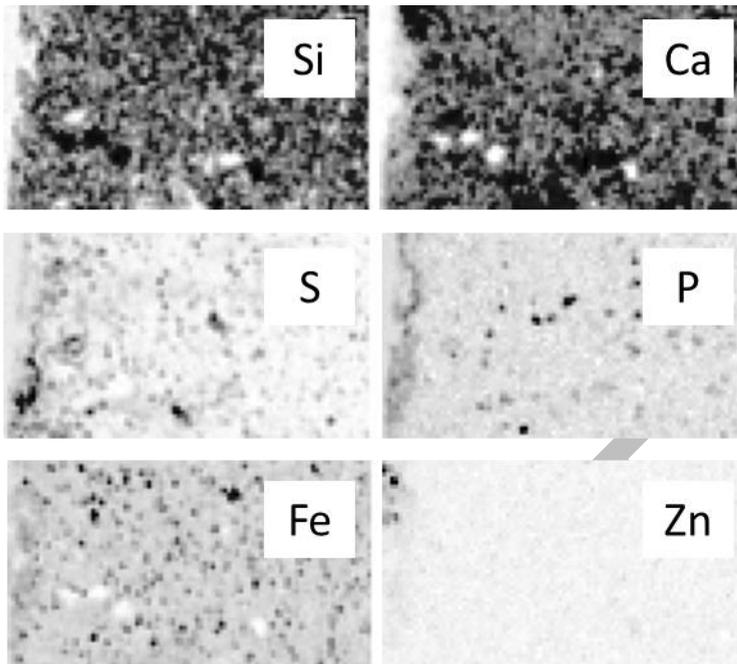
Loss on Ignition shows an average 1.0347 weight-% of organic matter present in the crust (Table 2). An elemental distribution map was obtained by μ -XRF mapping as seen in Figure 5. On these elemental distribution maps, a clear distinction between a superficial crustal layer and the more inner sound stone can be seen. The crustal layer is enriched in sulfur, phosphorus, and iron, while it is depleted in silica and calcium relative to the sound stone.

Figure 5. Elemental distribution maps. High concentrations are labeled in black, low concentrations in white. The crust is located on the left of the distribution map. The field of view is approximately 5.1 x 9.1 mm.

μ XRF data supplies additional chemical information. It reveals an enrichment in sulfur, phosphorus and iron and local zinc in the crust and a depletion of silica. The sulfur enrichment can be assigned to this gypsum. Inside the stone, there are some sulfur spots which can be attributed to secondary gypsum formation or to the mineral content. Only pyrite, observed in thin section, can cause a sulfur signal. This seems not the case however as the sulfur signal does not correlate with the iron signal and as the pyrite crystal sizes are an order of magnitude smaller than the XRF mapping resolution. Indeed, XRF measurements on the sound stone do not show these sulfur spots. So besides forming a superficial crust, gypsum also crystallized deeper inside the stone. The source of this sulfur is probably air pollution with SO_2 (Smith *et al.*, 2004). Release of sulfur by pyrite oxidation in the stone can only play a minor role as the pyrite amount is very low.

Distinct phosphorus enrichment is also seen in the crust. This was not detected with XRD, suggesting this phosphorus is not a crystalline material. The origin of this phosphorus enrichment is most probably due to biologic activity, such as algae growth or pigeon excrement. This phosphorus enrichment is only superficial and seems to do no harm to the stone.

The iron enrichment in the crust is less pronounced. This probably relates to a rusty patina formation, which is usual for the Lede stone. This patina is overprinted by the black crust, but is sometimes slightly visible beneath the crust in places where the crust is damaged. The patina is formed by iron oxyhydroxides which form after oxidation and leeching of the iron inside the stone. The most probable sources are glauconite grains as these minerals weather when a stone is exposed to atmospheric conditions. This weathering is observed in thin section when glauconite grains show cracks with the formation of brownish oxyhydroxides around the surface and in the cracks of the glauconite. Minor sources might be pyrite crystals and iron content of the carbonate cement. The origin of the local zinc signal is unclear. A possible source for this zinc deposition is earlier leeching from a nearby gutter.
