**LEARNING FROM THE PAST – A REVIEW OF TREATMENTS
CARRIED OUT TO CLUNCH IN 1985 AND FURTHER FIELD AND
LABORATORY INVESTIGATIONS INTO THE DECAY MECHANISMS**

David Odgers¹ and Trevor Proudfoot²

Abstract

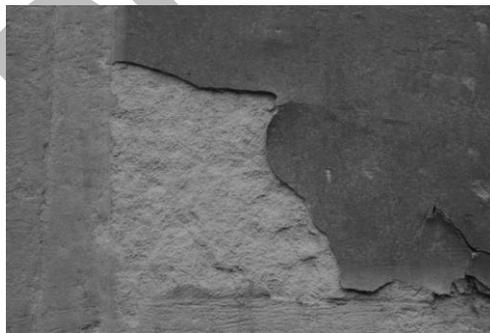
- c) Discolouration through various factors including soiling, sulphation and accumulation of biogrowths.
- d) Lamination of the surface to a depth of 2 - 5mm (Fig 3). Some stones are susceptible to lamination but others immediately adjacent (which are subject to the same environmental conditions) appear to be completely sound. Once lamination starts, it will tend to develop over the whole stone.

Fig 3. Typical lamination of surface of clunch

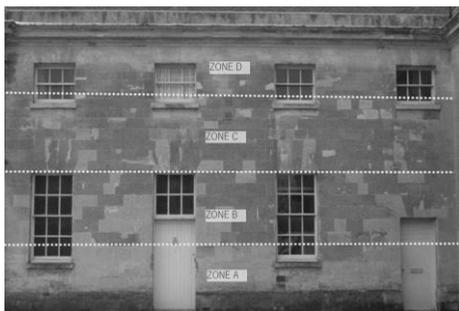
Fig 5. Elevation E22 of North Court

There are great benefits in overlaying notations of decay and surface changes on elevation drawings or photographs; patterns of decay become discernible and help direct the investigation. Decay mapping was carried out to indicate areas of lamination, powdering and to record previous repairs that had involved either tooling off the surface (to a depth of about 8mm) or replacement of the stone. This mapping revealed that the elevations could be divided into four zones (Figs 5 and 6):

Zone A – At low level and consists almost entirely of stone where the original surface has been lost and decay continues to underlying stone through spalling and powdering.

Zone B – Up to lintel level of ground floor windows; this has most of the stone showing either current or historic (often tooled off) lamination but with only individual stones exhibiting on-going spalling.

Zone C – Up to just above cill level of upper window; in this zone, the stone is mostly sound but with some individual stones having a laminated surface and localised decay beneath.

Zone D – Up to cornice level; this area is almost all sound and the more protected stone has original surface intact. This is also the area where surface coatings (limewash) are found.

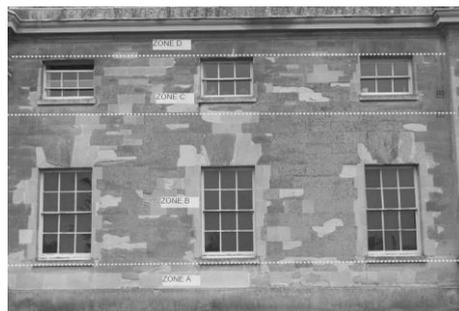
Fig 6. Elevation E04 (external) of north court

The difference between the two elevations is that in the more exposed elevation (E04), zones C and D are much narrower with Zone B being predominant. This reflects the greater exposure of this west facing elevation to rainfall and more regular regimes of wetting/drying and heating/cooling.

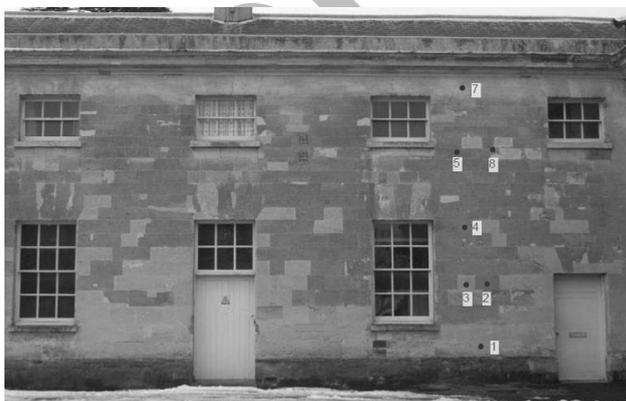
Fig 7. Location of porosity measurements in Bay E22

- No 1: Decayed stone from Zone A
- No 2: Sound surface (with brown biogrowth) in Zone B
- No 3: Tooled back surface in Zone B – adjacent to No 2
- No 4: Sound surface at top of Zone B
- No 5: Sound surface in Zone C
- No 7: Sound surface with coating in Zone D
- No 8: Laminated section of stone in Zone C

- No 1 (decayed stone with no intact surface) is the most permeable.
- Nos 2 and 3 show little difference suggesting that a tooled back surface eventually establishes a similar low permeability as stones where the surface remains intact.
- The stones at higher level (for example No 7 with surface coating) have higher permeability than others lower down; this suggests that the mechanism by which pore blocking takes place has not occurred to the same extent – either due to the protected location of the stone or the presence of the surface coating.

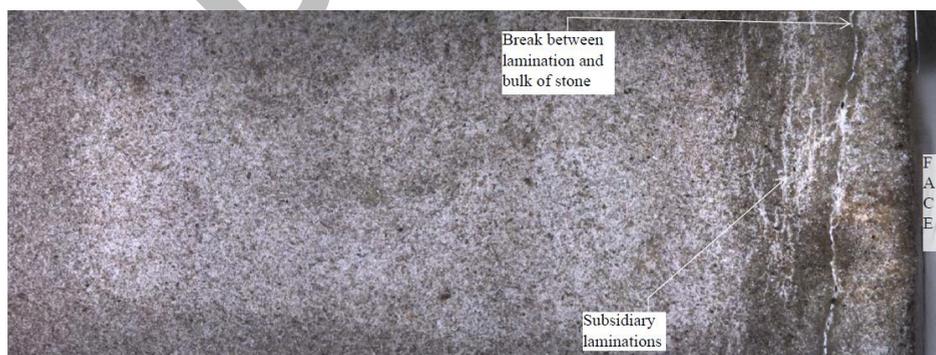
Fig 9. Cross section through core sample showing lamination near face

The areas affected by pore blocking have higher oxygen and lower calcium content. Without a greater number of absolute measurements, it is not possible to make any firm conclusions. However it reinforces the idea that some sort of change takes place near the surface, which leads to the laminations seen in many of the clunch stones at Woburn.

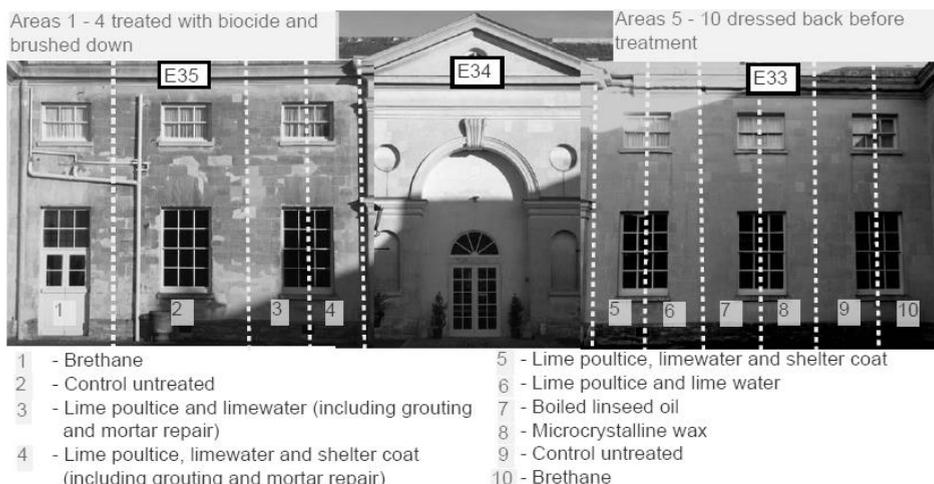
Fig 11. Diagrammatic representation of the trial treatments carried out in 1985

Area no:	Treatment in 1985	Observation
1	All loose and flaking material was removed. Edges of all flakes were cut back to sound material using a chisel to form a neat splayed edge. Panel was thoroughly brushed down prior to treatment.	In the 25 years since application, there has been no further decay except under a x10 magnifier, it is possible to see very small flakes beginning to develop at low level. Because of the presence of a lead catalyst in the Brethane, there has been no microbiological growth on the surface.
2	Control – no treatment (except biocide)	Lamination and flaking has continued. Brown surface of biological growth indicates biocide had limited effect.
3	Lime poultice (lime putty applied to thickness of 15mm, sheeted in plastic and removed after two days), lime water (40 No applications) and lime	Although some laminations remain intact, almost all of the mortar fillets have detached or decayed. All laminations sound hollow indicating that grouting

mortar repairs and grouting (stone consolidated without redressing or removing surface; edges were supported with lime mortar fillets and voids grouted).	has not arrested the separation. Colour of surface slightly lighter than control.
4	Lime poultice, limewater, mortar repairs and grouting (all as area 3) plus lime casein shelter coat	Apart from tiny traces in protected areas, there is almost no evidence of any shelter coat remaining. Although some laminations remain intact, almost all of the mortar fillets have detached or decayed. All laminations sound hollow indicating that grouting has not arrested the separation. Colour of surface slightly lighter than control
5	Lime poultice, limewater, mortar repairs and grouting (all as area 3) plus lime casein shelter coat.	When compared to the control area, there is no obvious difference in appearance or extent of decay. Only very small traces of shelter coat remain in protected areas.

6	Lime poultice, limewater, mortar repairs (all as area 3)	When compared to the control area, there is no obvious difference in appearance or extent of decay
7	Boiled linseed oil applied by brush (similar to the treatment applied at that time to all new stonework at Woburn)	This bay has continued to decay at a faster rate than either the control area (area 9) or the area treated with wax (area 8). There is some surface discolouration when compared with adjacent areas.
8	Microcrystalline wax dissolved in white spirit and applied by brush. Then well rubbed in with a soft cloth and surplus removed.	There is no noticeable discolouration of this area although it still appears to retain a slight element of water repellence (see 'Permeability' section below). There appears to be less on-going decay than in the control area.
9	Control – no treatment	Lamination (albeit localised) continues to develop.

10	Brethane	There has been no deterioration of the surface at upper level where

the stone remains clean but at lower level, the surface has darkened when compared to the adjacent control area.
--	--	--
