STUDY ON THE DETERIORATION AND CONSERVATION OF THE VAULT OF THE ROOM OF PLENARY SESSION OF THE TOWN HALL OF SEVILLE

Dolores Robador,¹ Fátima Arroyo² and Almudena Muñoz¹

Abstract

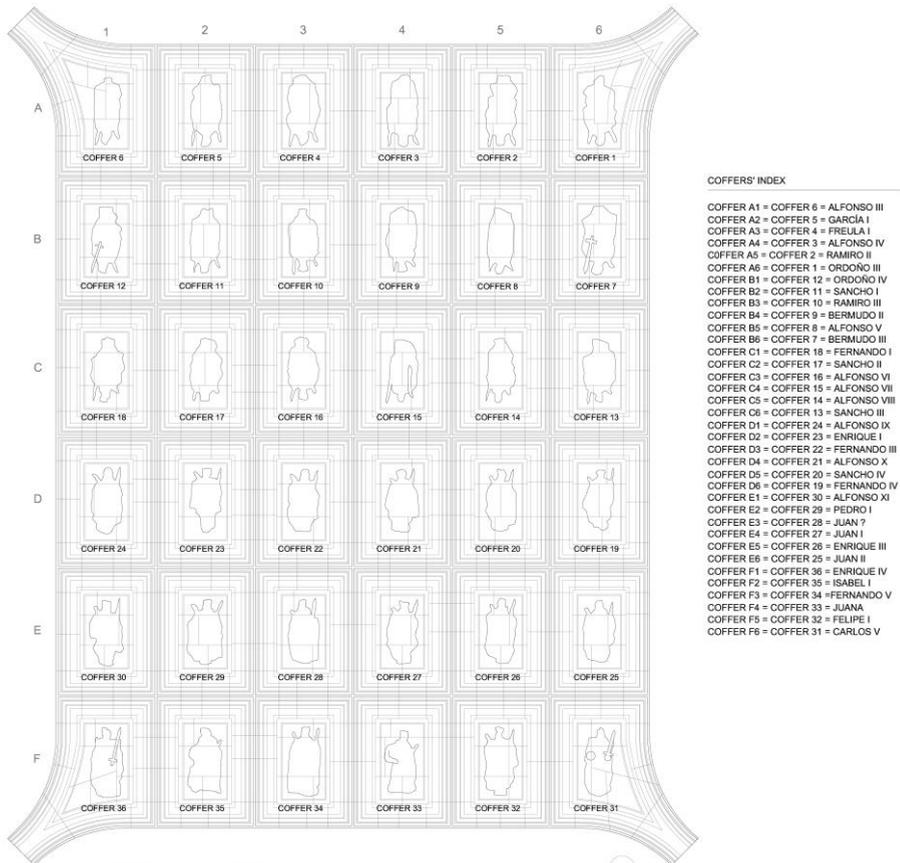
Figure 1. Vault scheme

The room shows a slightly rectangular plant (10.94 x 8.27 m.), covered by a vault showing an orthogonal grid composed by thirty-six coffers which are decorated with Castilian and Leonese queens and kings (Figure 1).

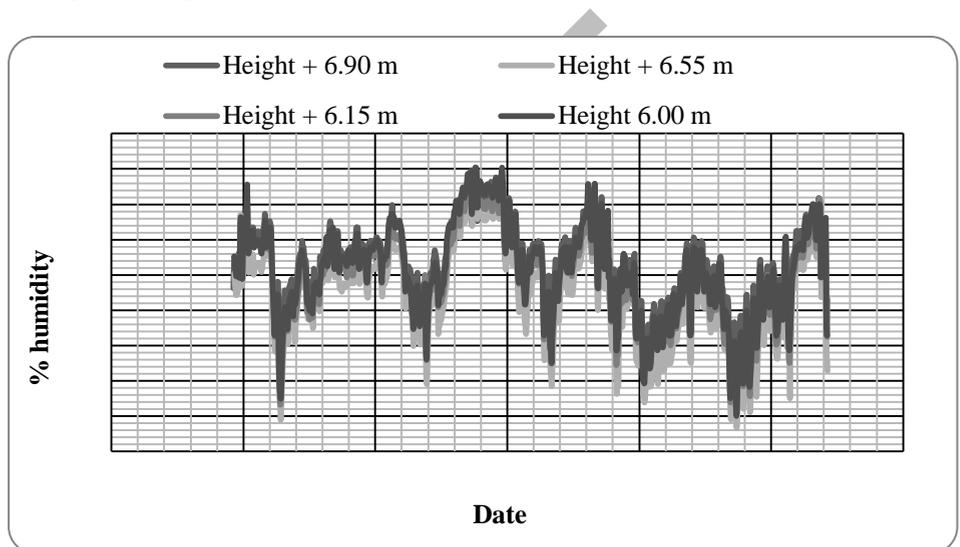
Figure 2. Environmental humidity in the plenary session's room from March to June 2006

Important deviations of temperature and humidity occur in certain specific dates, especially on Thursdays, when the plenary sessions are usually celebrated.

The evolutions of temperature and humidity during the whole day show that the temperature increases early in the morning, probably due to the heating system (and the corresponding decrease in humidity). From 9.30 a.m., the starting time of the session, the humidity increased up to the 14.30 a.m., probably when the sessions ended.

Probably there is a direct relationship between the disjunctions in the vault and changes in temperature and humidity. Therefore a climate control is necessary to reduce the changes in humidity and temperature, and especially the possible condensation, and high humidity values.

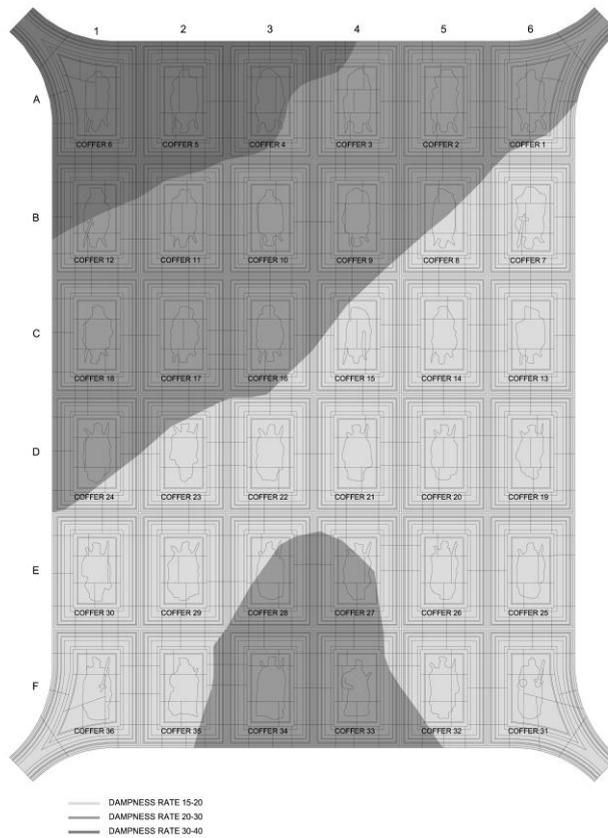
Figure 4. Dampness rate in the stone of the vault

The dampness and salts inside the stone were measured. The obtained values of both dampness and salinity rates are presented as indexes on a scale of 0 to 100. They have a qualitative value, useful for comparisons between areas or dates. Measurements are shown in Figures 4 and 5.
