## OUTSIDE THE CANON: A REVIEW OF UNIQUE APPROACHES TO STONE CONSERVATION

Justine Posluszny Bello,<sup>1</sup> Daniel Lane,<sup>1</sup> Mark Rabinowitz<sup>1</sup> and Joseph Sembrat<sup>1</sup>

<sup>1</sup> *Conservation Solutions, Inc.*

**12th International Congress on the Deterioration and Conservation of Stone  
Columbia University, New York, 2012**

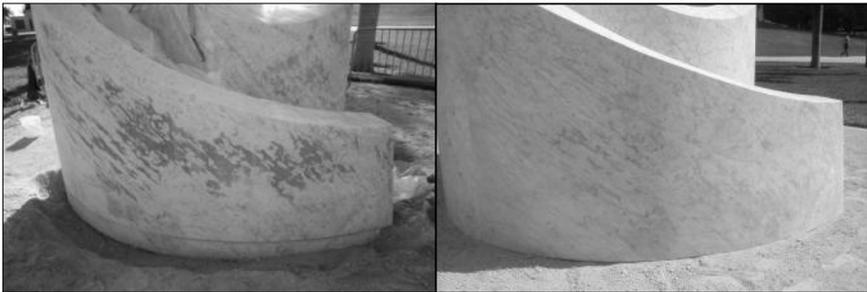
**Figure 1, 2.** Disfiguring biological staining before (left) and after (right) treatment with CB-4 bacteriostatic detergent.

Uniquet CB-4 is a bacteriostatic detergent that penetrates microbiologically influenced biofilms. Although initially developed for the purification of water wells, consultations with the manufacturer suggested that this cleaner could be effective in removing tenacious biological soiling in and on stone surfaces as well. The action of the detergent leads to three major impacts: (1) the breaking apart and dispersion of the biofilms; (2) the destruction of the microbial cells particularly when the concentrations applied exceed 0.5%; and (3) dispersing attached materials formed by the infestation and growth of microorganisms associated with the biofilms. In general these impacts on the entrenched biofilms on surfaces require sufficient retention times to allow each of the three events listed above to be completed in the appropriate sequence. In water wells and pipelines the retention times vary but the ideal should be 12 to 24 hours for each stage. This allows enough time for the CB-4 to effectively disperse the infesting biofilm and associated concretious chemical accumulates; effectively reduce the active cells by at least three orders of magnitude; and then disperse attached materials from within underpinning surfaces (e.g. eroded pores into the marble).

The material was tested in sequence with other common detergents and quaternary biocides. Cleaning was effected first with a surfactant (Triton X-100, 3% solution) then a quaternary biocide (D/2 Biological Solution, 50% solution) followed by applications of CB-4 (5% solution, paper poultice, wrapped in plastic sheeting for a 24-hour dwell time). It is believed that the detergent removes surface soiling and exposes the biofilm. D/2 penetrates and disrupts the biofilm and biomass. The CB-4 acts as a penetrating biocide which attacks the structures formed on and beneath stone surfaces. These structures then collapse and can be easily removed by light scrubbing/ rinsing. This combined technique was used successfully to significantly reduce red-orange microbiological staining on the white marble sculpture *Slide Mantra* (Isamu Noguchi; Miami, FL), previously thought to be an intractable problem (Konkol et al. 2009). The authors have also used this method selectively on the New York Public Library Lions and elsewhere.

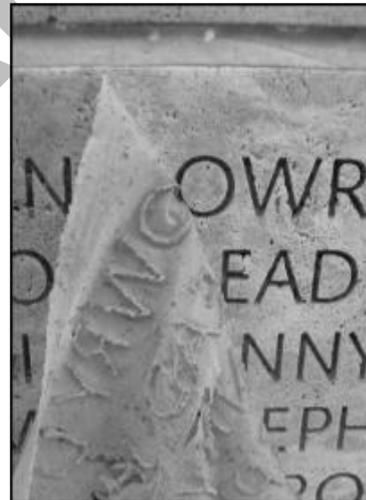
**Figure 3.** Prestor gel being pulled from the surface of the National Law Enforcement Officers Memorial, Washington, DC.

Both the dwell time and maintenance of physical contact with the substrate without drying are critical for the effectiveness of CB-4, which was designed to be used in water wells. A paper poultice contained in plastic sheeting was only partially effective at achieving this goal, particularly on vertical surfaces where it tended to lose adhesion and pull away. It relied solely on the penetrating capacity of the CB-4 to reach the microbiota, which proved generally effective on the smooth surface of the *Slide Mantra*. However, the highly porous Adair marble National Law Enforcement Officer's Memorial (Washington, DC) exhibited similar soiling conditions with a much more challenging surface. Further, the paper poultice method did not inherently remove the killed biota afterwards, thus leaving nutrient-laden beds, which encourage re-infestation and return of bio-soiling. Both the effective killing through prolonged contact of the biocide with the biota, and the removal of the killed infestations within the pits, were problematic and necessary to the treatment goals (Rabinowitz et al. 2011). This was achieved by modifying the process through the use of Prestor Gel (CBI Polymers, Honolulu, Hawaii, USA) as the transmission agent for CB-4 as a replacement for the paper poultice.

The product, based on a material developed to decontaminate nuclear sites, is a polymeric gel that has the capacity to wick into microscopic pores. Unlike other commercially available gel-cleaners, which are typically latex rubber-based and polymerize into an elastic film, Prestor is water-based and water-soluble, and offers much greater mechanical cleaning ability through its tenacious cling to and pull from the surface. It readily clings to vertical and overhead surfaces, although its relatively low viscosity necessitates careful site protection and application methods. As it dries, it shrinks approximately 20% and forms a tough, pliable skin that encapsulates anything contained within it. After approximately 24 hours, depending on environmental site conditions, the gel can be peeled away and disposed. This period corresponds to the necessary dwell time for the CB-4, meaning that it can be used to both ensure the CB-4 has sufficient contact time to effectively act upon the bio-colonies as well as remove them afterward, potentially reducing re-soiling rates. One year after treatment the stone of the Memorial remains unsoiled, confirming this effect. Please note that the tenacious pull of the gel is not appropriate for friable substrates and should only be used on sound, dense stones.

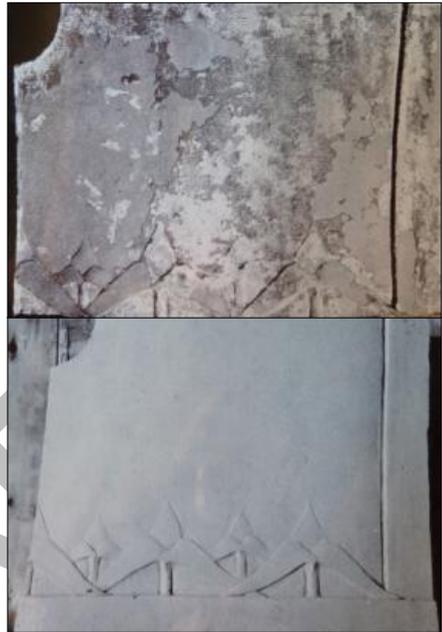
**Figure 4, 5.** Panel encrusted with calcium and magnesium deposits before treatment (above) and after successful ultrasonic cleaning (below).

Ultrasonic cleaning utilizes high frequency sound waves passed through a water medium aided by a cleaning agent to effectively remove soiling, commonly used on jewelry, industrial equipment and sensitive electronics. The authors have also experimented with expanding this technology for use in the cleaning of masonry materials, including limestone and terra cotta. Ultrasonic cleaning is necessarily limited by the size of a vessel that can contain the object to be cleaned; it also requires a significant investment in equipment (transducers). Despite these potential hurdles, the authors saw an opportunity for ultrasonic cleaning of terra cotta and limestone elements from the Four Seasons Fountain in Ames, Iowa. At this site, the decorative fountain elements had been marred by an accumulation of iron stains and calcium carbonate deposits due to hard water and deterioration of the internal plumbing system.

Typically, stains and deposits of this nature might be broken down through the use of strong oxidizing acids, or mechanical means such as abrasive blasting. These methods, while effective, can also render permanent damage to the underlying surfaces. Ultrasonic cleaning was explored as a way to effectively reducing this soiling without introducing damage to the substrate. Through a sequence of testing using different ultrasonic frequencies, water temperatures, and cleaning agents, parameters for treatment were established. It was determined that frequencies in the range of 38-42 KHZ afforded effective but not overly aggressive cleaning, aided by Branson OR, a proprietary, citric acid-based cleaning solution. Water temperature was maintained at 150°F and a pH of 4-4.2. Each element was situated in the custom-built ultrasonic tank and cleaned for successive 1-hour intervals, which typically totaled 6-8 hours of treatment overall. After cleaning, the element was transferred to a rinsing bath of deionized water. The net findings were that the ultrasonic cleaning was highly successful at effectively cleaning terra cotta surfaces without damaging the substrate, however, this cleaning method was not initially successful at reducing the same deposits on the softer, more delicate limestone (Sembrat 1998). Additional research will be needed to evaluate appropriate ultrasonic frequencies, duration of cleaning cycles, and cleaning agents to effectively clean limestone and other

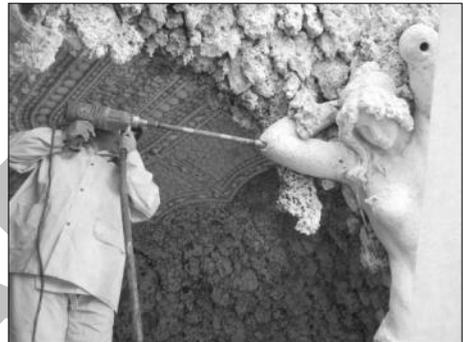
**Figure 6 (above).** Core drilling a sculpture to facilitate installation of a grouted anchor.

Grouted anchor systems, in a variety of proprietary iterations, have been used over for more than 20 years to effectively stabilize historic masonry structures by “stitching” together unstable walls, particularly those with internal voids or poorly bonded courses. Due to concerns about the use of synthetic adhesives for bedding anchors, the authors have also successfully extended this technology to the internal stabilization of compromised stone sculptures. The goal is to replace the epoxy binder with grouts whose thermal expansion and moisture transmission characteristics are closer to those of stone. For installations other than vertical cores that are accessible from the top, this process requires bedding the stainless steel anchor within a polyester fabric sleeve,

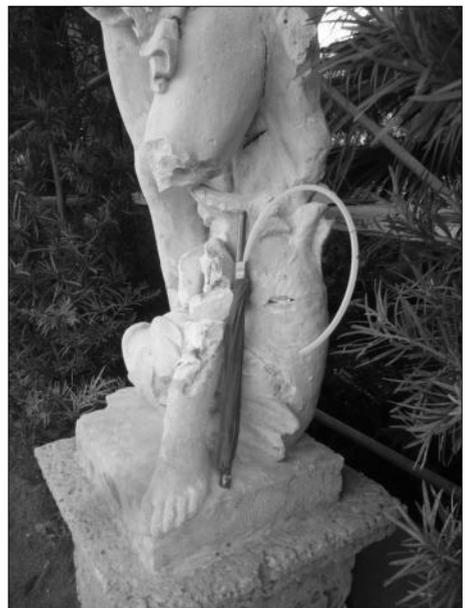
**Figure 7 (below):** A grouted anchor system prior to installation.

then inflating it by injecting a cementitious grout under low pressure. The sleeve expands with grout to fill the hole as the fabric is inflated. Some grout leaches through the fabric, which allows the paste to adhere to the core walls while containing the aggregates within the sock. With the sleeve's flexibility, it is able to mold into the voids and spaces within the sculptures, allowing it to be used to pin and reassemble fragments while minimizing or excluding the use of epoxy. The sock also allows for installation in conditions that would not otherwise be feasible, such as horizontal or upward cores, where grout would simply run out of the holes if not contained (Cintec 2012). The system has been used to pin stones on the Barnard Statuary Groups at the Pennsylvania State Capitol (Harrisburg, PA); the Tripoli Monument at the US Naval Academy (Annapolis, MD); cast stone reliefs by artist Constantine Nivola at Yale University (New Haven, CT); and on several travertine, coral stone, and Vicenza stone sculptures and fountains at Vizcaya Museum & Gardens (Miami, FL).

The flow capacity of the grout and its ability to remain viscous and not separate during installation are essential characteristics. Presstec grout used as part of the Cintec system is the only grout the authors have found with these characteristics. Where there have been concerns about possible differential compressive strength or when used to repair narrow stone units, such as in the repair of the pedestal supporting a basin within a marble fountain at Kykuit in Tarrytown, NY, narrow closed-cell foam backer rods have been inserted into the holes parallel with the anchors to act as bond breakers and to allow for and absorb some expansion, minimizing stress on the surrounding stone.

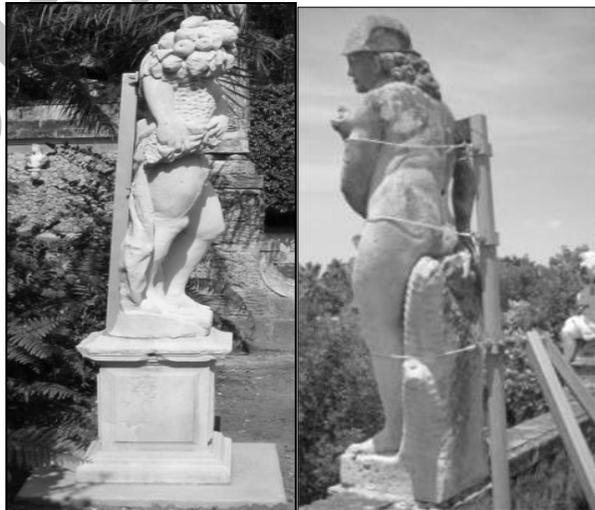
**Figure 8. (left)** Example of a strongback mounted to the sculpture of *Pomona*, an example of a sound sculpture secured to a new concrete footing.

**Figure 9. (right)** Example of a low-impact strongback in which nylon-coated stainless steel cables were used to secure a sculpture on a roof parapet.

A strongback for a sound sculpture with an adequate footing and mounting consists of a solid stainless steel bar, approximately the height of the figure, mounted vertically behind the sculpture, generally following the profile of the base and sculpture, which is set into a reinforced concrete footing. The bar is connected to the figure with several strategically placed reinforcement points, located at or above the mid-section and middle-upper back. Neoprene pads may be set between flanges on the bar and the stone sculpture to provide cushioning. Ensuring the rigidity of the post allows for use of a rigid mounting bolted to the sculpture. For example, the sculpture of *Pomona* located at Vizcaya Museum & Gardens features a strongback that was welded to an internal grouted anchor which continued through the base of the sculpture and was embedded in a newly poured concrete footer upon which the entire sculpture assembly was positioned. Due to the frequency with which the authors have had to implement this kind of support in the Miami, FL area, they have worked with a structural engineer to develop a design which has been engineered to withstand the Florida Building Code requirements for high velocity hurricane winds. The system presumes that the sculpture is itself well-supported.

An alternate design has been used in situations where it is not possible to confirm that a sculpture is soundly mounted. To avoid excess loading at bolt points when some movement may be encountered from high winds, a similar bar is used but it is only attached to the sculpture with surrounding cables. Coated aircraft grade stainless steel cable is looped around the figure at several locations and connected to flanges on the vertical bar. On a roof top, this bar is also braced with diagonal supports, all bolted to the roof deck and waterproofed. The cables are kept snug against the figure but not overly tightened. The cable shield consists of semi-transparent nylon, which can be painted if needed to blend with the sculpture. This design is intended to support the sculpture against catastrophic loss in a severe wind event while allowing for some rocking or movement. It has proved effective on parapet figures, where some evidence of rubbing of the cables against the stone five years after installation demonstrates that movement has occurred. Ideally, the work should be hoisted and securely pinned as well as provided with a strongback if needed but, in situations where this is not feasible, this method may be used. In conditions where previous strongback installations have already failed, leaving weakened and cracked stones that cannot safely be pinned unobtrusively, it may be the best available method to prevent disastrous loss and limit threats to

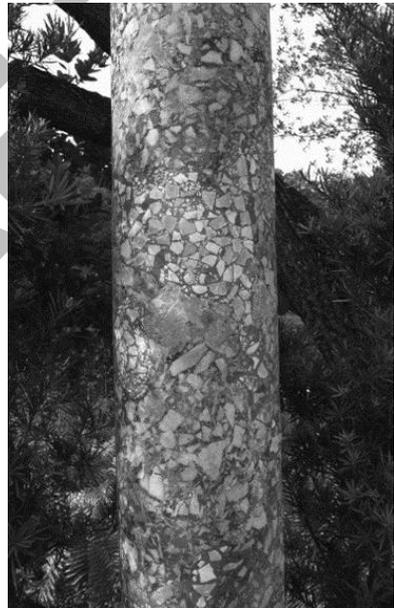
**Figure 10.** Example of a sample stone mosaic repair held in front of the host stone for comparison.

Major losses on brecciated marble columns at Vizcaya Museum & Gardens were rebuilt either by creating a terrazzo-like patch or creating a mosaic matrix. On the mosaic patches, a variety of stones comparable to the range exhibited in the existing column were selected and broken or cut to create tesserae that matched the shapes in the original stone. Once the void was properly cleared and prepared for repair, a colour-matched acrylic-modified grout was laid into the void to serve as a bedding mortar and the stone tesserae were set in it slightly proud of the profile to approximate the colour, veining, and texture of the natural stone. Joints were grouted with the same mortar used in the bedding. Once the grout was set, the entire patch area was honed down using a wet-polisher equipped with a 50-grit diamond bit pad. Care was taken to ensure the patch repair was shaped to match the round profile of the column. Final dressing of the patch was done using sequentially finer pads up to 2000-grit. Care was taken to ensure adjacent surfaces of the column were not abraded during this process. Any minor losses of tesserae or voids in the grout were filled with additional material and screeded flush.
