**BIODETERIORATION OF STONE IN RELATION TO MICROCLIMATE
IN THE TA NEI TEMPLE – ANGKOR (CAMBODIA)**

Abstract

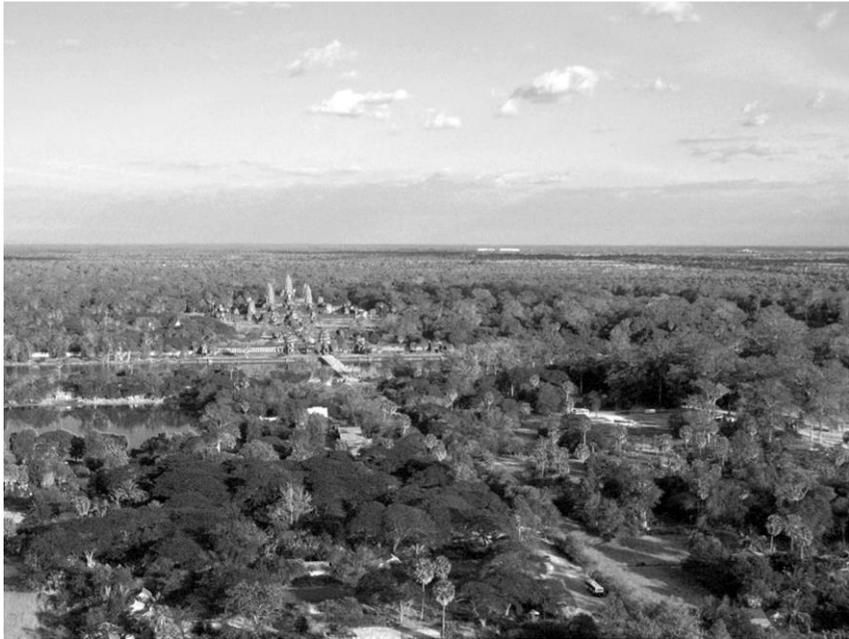
Figure 1. Angkor site, aerial view. The Angkor Wat temple is visible due to the forest cutting. Many other temples, such as Ta Nei, are still covered by a thick tree cover.

moment, part of the archaeological area has still to be excavated and great trees cover remains around the main monuments, giving to the place a suggestive impression, however causing also cracks and fall down of the constructive materials (Fig. 1).

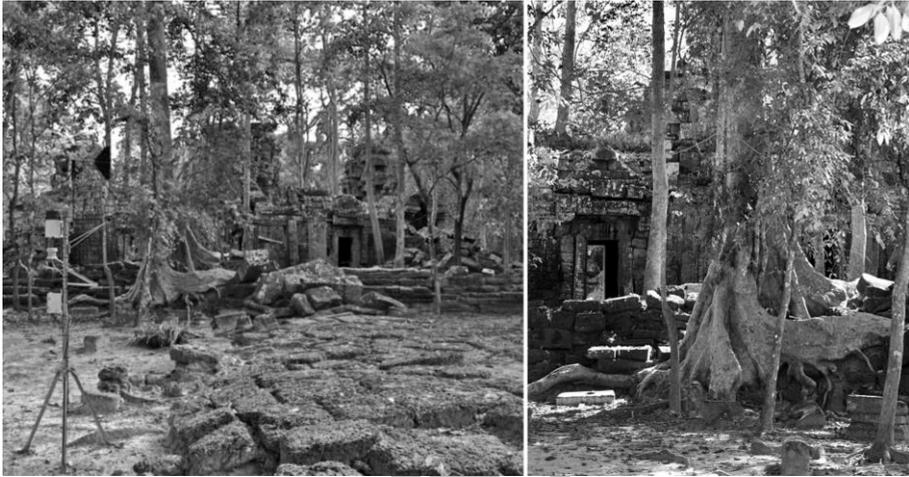
Figure 2. The West side of Ta Nei temple, where one of the microclimatic stations was settled. Note the diffuse collapses and cracks on the walls, and stone surfaces widely covered by different biological colonisations.

Within the cooperation activity of the Japan team with the APSARA Cambodian authorities, in the field of the effects of microclimate on the stone of the monuments, Ta Nei temple (north east of Prasat Ta Keo in the Angkor Archaeological Park) was selected as a case study representative of stone conservation in shady conditions. This temple is still surrounded by a luxuriant forest and not only big trees are growing on and all around the monument, but also different patinas of algae and cyanobacteria, lichens, mosses and higher plants are colonizing the temple stones (Fig. 2).

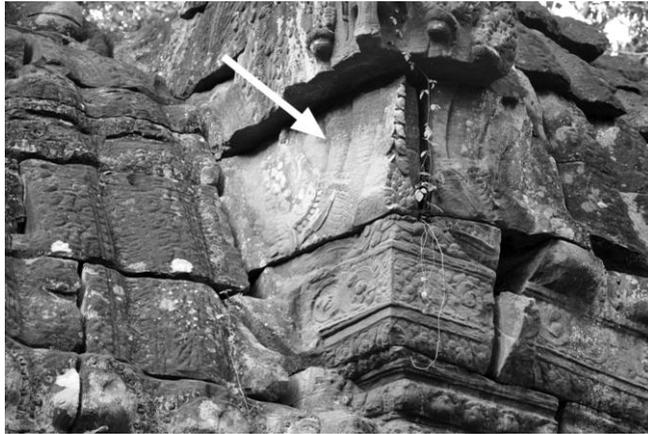
Figure 3. Stones protected from water percolation, and free from epilithic microflora.

Excluding few areas where the water input was very low, and stone appeared macroscopically free from biological growth, in the other areas, biological patinas, lichens and cushions tuffs on the surfaces were very evident. In fact, areas protected from rainfall, as incident water input or through percolation, are free from biodeteriogens, or their growth is very low (Fig.3). This means that water is here the main limiting (ecological) factor and the first step of biological colonization arises only starting from a certain water input in the substrate.
