**DAMAGE ASSESSMENT OF FERRUGINOUS SANDSTONE  
BY X-RAY TOMOGRAPHY-  
THE “VIRGIN TOWER” OF ZICHEM (BELGIUM)**

**Abstract**

**12th International Congress on the Deterioration and Conservation of Stone  
Columbia University, New York, 2012**

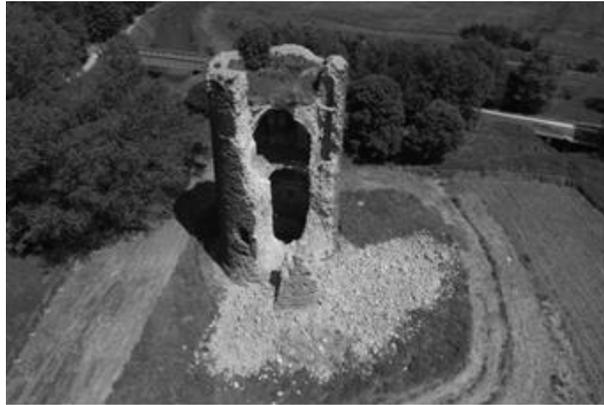
**Figure 2.** Virgin Tower at Zichem, an abandoned medieval four stage dungeon erected in the 14th century, after its partial collapse in 2006 due to loading by roof breakdown, important soil deposit and long-lasting water infiltration. The structure has since been consolidated in its present form and protected against further infiltration. The present study deals with the standing walls not affected by the collapse.
