**ASSESSMENT OF XIX-XX CENTURIES CONSERVATION INTERVENTIONS
IN VENETIAN STONE MONUMENTS WITH ARTIFICIAL PRODUCTS:
STATE OF THE ART AND PERSPECTIVES**

**12th International Congress on the Deterioration and Conservation of Stone
Columbia University, New York, 2012**

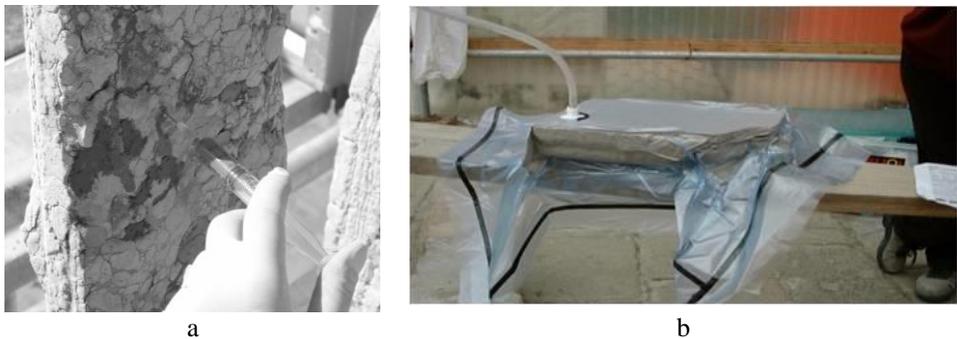
Figure 1. Consolidation with fluid inorganic mortars on the thin spires of the roof of the Doge's palace (a) epoxidic treatment in San Geremia Church (b).

Two examples of the first approach are (figure 1):

- the restoration of the thin spires towering over the roof frame of the Doge's Palace in Venice, enveloped by a sheath of thin stainless steel mesh and consolidated only by lime mortar. (Menichelli et al. 2010)

- The restoration of the façade of San Geremia Church (1998) deeply damaged by an arson, that dramatically modified the architectural structure of the building and substantially changed the chemical and mechanical properties of the Istrian stone. For this reason, an application of inorganic mortars was preferred to the use of an epoxy resin, which at the beginning was used (cycloaliphatic epoxy resin) (figure 1.) Mortars with different characteristic of resistance, adhesion and fluidity were used in different parts and moments of restoration. The US data show a very good consolidation, at least in the 57% of the investigated areas (Bassotto et al. 2007)

Another good example of this fruitful discussion is the restoration of the thin spires towering over the roof frame of the Doge's Palace, where the use of polymers in a complex situation (sun and heat exposure, mechanical stress) was discarded in favor of more safe mechanical devices to ensure stone cohesion. (Menichelli et al. 2010)
