TEMPERATURE IMPACT ON COTTA SANDSTONE

Christoph Franzen,¹ Dana Krause,² Heiner Siedel³ and Bernd Ullrich³

Keywords: building stone, fire damage, historic material, sandstone deterioration

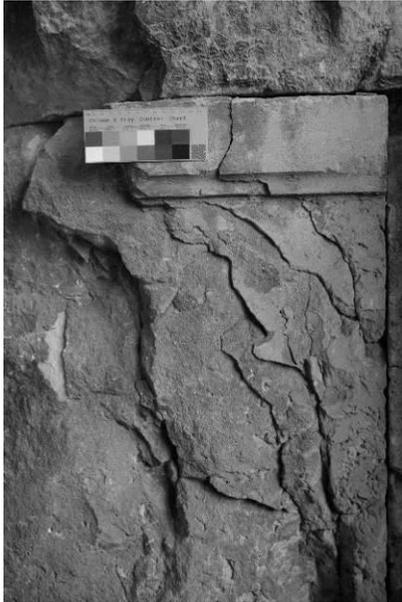
Figure 1. Loss of pieces of several cm in thickness parallel to surface, typical fire damage, Dresden, Palais im Großen Garten.

Several historic buildings suffered fire damage in their history. Also lots of sandstone monuments were affected by fire and high temperatures due to bomb attacks during the 2nd world war in Dresden. Some of the fire effects and damages are still observable (Figure 1 to Figure 3). Elbe sandstone is the main building material in Dresden since the 16th century (Siedel 2010a).

Main damages on sandstone as building material, what we focus on here, are fracturing and loss of those surfaces which were directly exposed to the temperature impact. Most often pieces of several cm in thickness lose completely the contact to the stone core and fall apart (Figure 1, Figure 3). Regularly a kind of layering parallel to the surface is visible (Figure 1). Also typical is a red staining of the stone material.

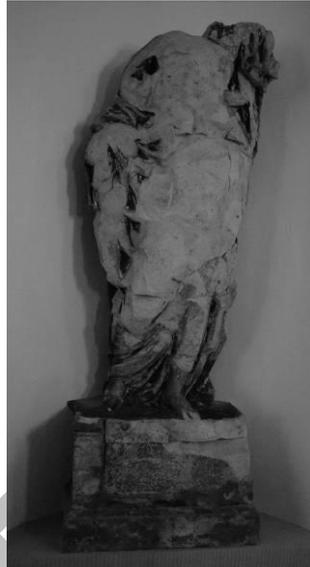
Figure 2. Fire damaged sculpture of Justitia, Residenzschloss Dresden.

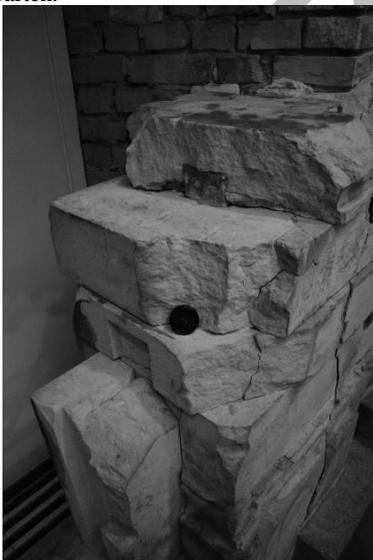
Figure 3. Fire damage on masonry, Lepsius Bau, Dresden.

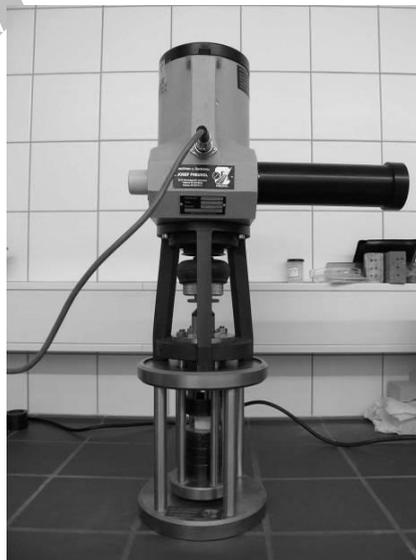
Figure 4. Haft- Zugmessgerät Type F20D Easy, Firma Josef Freundel Maschinen- u. Gerätebau.

Compressive strength was tested by means of a Haft-Zugmessgerät Type F20D Easy, Josef Freundel Maschinen- u. Gerätebau in Wennigsen (Figure 4). The sample (20x20x20 mm) is placed in a hanging cylinder which is torn upwards with defined force in time. Maximum load was 20 kN.
