**INTERIOR CLEANING AT SAINT JOHN THE DIVINE:  
PRACTICAL AND LOGISTICAL CONSIDERATIONS**

**12th International Congress on the Deterioration and Conservation of Stone  
Columbia University, New York, 2012**

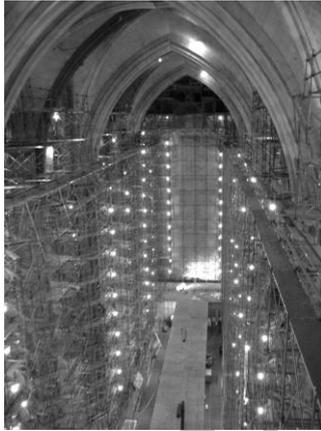
**Figure 1.** View of scaffolding at nave. Center aisle is open with plywood-roofed pedestrian walkway. Plywood secured to pipe frame, visible at center rear, provides separation between nave and crossing. Photograph by the author.

During the restoration, surfaces were accessed primarily using stationary pipe frame scaffolding. The pipe frame enabled containment of discreet work areas and permitted the contractor to access many areas simultaneously. It also facilitated design team review of completed areas while work was progressing in new locations. At the perimeter, pipe frame was erected to the full height of the nave, crossing, and great choir/high altar walls. A rolling platform, sized to fit within two bays of the nave and set at approximately 30 m – near the spring point of the nave vaults – allowed for access to the nave ceiling while keeping the nave's center aisle free for pedestrian traffic (Figure 1). Stationary pipe frame was also erected across the full width of the building at the juncture of the Nave and the Crossing. This portion of the pipe frame was necessary to reach certain otherwise inaccessible surfaces. It was also used as a physical separation

between work areas and areas open to the public. Sheets of plywood were secured to the pipe frame, forming a solid wall; when work shifted from the crossing to the nave, the plywood was moved from one face of the pipe frame to the other.

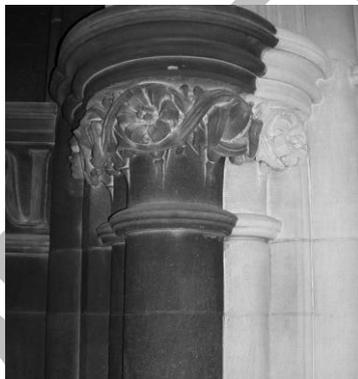
**Figure 2.** Detail of limestone surface cleaned by Arte Mundit adjacent to uncleaned section of stone. Photograph by Andrew Wilson.

Because the Arte Mundit cleaning system was relatively new at the time of the project, the project team had little product-specific experience to draw upon. On-going evaluation of material and constructability issues during the creation of a large-scale mock-up and throughout the course of the work resulted in modifications that improved both efficiency and results. Ultimately, Arte Mundit was successfully used to clean the limestone and Akoustilith-clad interiors of Saint John the Divine (Figure 2). The lessons learned can be utilized on future projects.
