**NATURAL STONE MONITORING – INVESTIGATION METHODS FOR A
RELIABLE EVALUATION OF THE EFFECTIVENESS OF CONSERVATION
MEASURES**

**12th International Congress on the Deterioration and Conservation of Stone
Columbia University, New York, 2012**

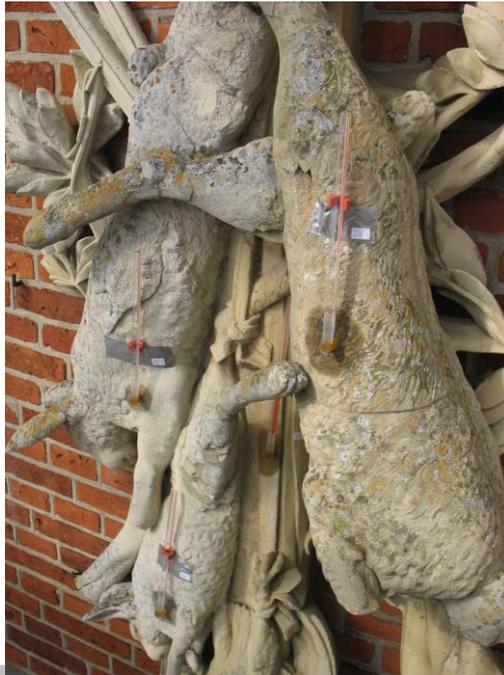
Figure 1. Example of application of the Mirowski tube (photo R. Wennemer)

In the context of natural stone monitoring the determination of capillary water absorption is most importantly because lots of non-destructive measurements can be carried out again and again. Normally the Karsten pipe is used for capillary water absorption measurements. Two programs are available for evaluation of the measuring data: both are based on Microsoft Excel®. One has been used satisfactorily for many years (the Calkarow program in the current version 3.2 from Wendler and Pfefferkorn) and there is now the newer evaluation algorithm of Niemeyer (2010). Both programs are based on the supposition of an even, direction-independent migration of water in the porous structure of the stone material according to capillary rules. As Calkarow has generally been used for many years and sometimes unrealistic water-absorption capacities and b-values are the result, the assessment of the w-value by Niemeyer is a new approach. With this program the w-value is not only determined mathematically as with the Calkarow program, but visually assessed by comparison of the measured values portrayed on a graph with several generated graphs. For more detailed information see the publication Leitfaden Naturstein-Monitoring (The results of the DBU-project are published in this “Guideline for Natural Stone Monitoring,” issued in 2010 by Fraunhofer IRB Verlag Stuttgart (Auras et al 2010)). On sculptures with small-scale surfaces, the Mirowski pipe was used in the project. This pipe also consists of a graded tube, though the upper end is sealed airtight. In the lower end there is a sponge. After the tube is filled with water, the sponge is brought into contact with the stone surface. For the application of the tube to the stone surface, a supplied device consisting of a clamp and two needles in combination with a rubber band (see fig. 1) or a lab-rack is used. The developing lower pressure is compensated by the air supply through the sponge. As an effect of water absorption, a wet zone forms around the pipe. From its diameter, the water absorption degree and direction can be determined. Comparing the dampened volume (V_0) with the amount of the absorbed liquid (V_f) gives the volume-related liquid absorption capacity (F_v) using the equation $F_v = V_f \cdot 100 / V_0$. In contrast to the Karsten measurement, for the Mirowski pipe the amount of water absorbed is proportional to the duration of soaking. Thus, the calculation of a water absorption value per hour [ml/h] is possible. This value is not directly comparable with the results of Karsten measurements (w-value).

complicated. Furthermore, sometimes residues from the putty stay on the surface and must even be retouched subsequently. Regarding these two circumstances Mirowski measurements prove to be a good alternative to Karsten measurements, even though their results are not comparable to w-values, which again are related to the assessment criteria set out below (see Tab. 2).

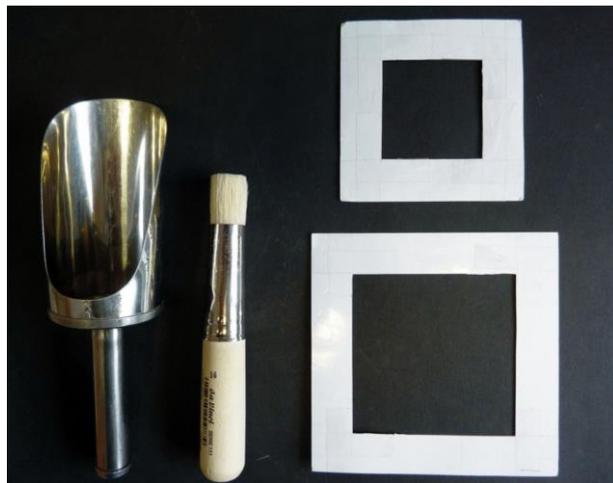
Figure 2. Utensils for the abrasion test

For the determination of granular disintegration near the surface, the abrasion of the loose surface with a small brush has been tested (see fig. 2). Therefore, a defined surface

area (template 10x10 cm for masonry stone surfaces, 5x5 cm for sculptures) was brushed off with a brush of exactly defined stiffness (da Vinci No. 14, series of 111). The brush was swept 10 times vertically and 10 times horizontally across the test surface. The released material was filled in a lockable box. The weighing took place after drying the material at 60°C. For the evaluation of the measurement, the quantity of the brushed-off material measured in grams is related to the test area (100 cm² or 25 cm²). Particularly on sculptures, a conversion of the result to kg/m² leads to an overestimation of the extent of the damage, because not the whole surface of the sculpture is affected by the same disintegration process.

Using this test, an objective description of the degree of granular disintegration is possible. A precise evaluation with respect to removed or disintegrated grain-layers is problematic. However, from the quantity of the brushed off grains and the bulk density of the respective stone material, the thickness of the removed layer can be calculated. On the assumption of an average grain size (e.g. Grimm, 1990) at least the number of grain layers could be approximately calculated. Problems with this evaluation algorithm exist when vegetation or biological crusts lead to an incorrect result. For magmatic stones such as Tuff and Trachyte no average grain size can be determined, so that this calculation cannot be applied. The reliability of the evaluation regarding the grain-layers must still be verified by further applications.
