**ON THE CONSERVATION OF GUADALAJARA, MEXICO BUILDING
STONES WITH A NEW ALUMINOSILICATE COMPOUND**

A procedure to understand and consolidate the volcanic tuff used in ancient churches and other historical buildings in Guadalajara is proposed. Initially, the deterioration mechanism of the local tuff was determined through textural, morphological and structural characterization. The techniques employed were, among others, ²⁹Si and ²⁷Al magic angle spinning nuclear magnetic resonance (MAS NMR), infrared spectroscopy (FT-IR ATR), X-ray powder diffraction (XRD), nitrogen adsorption-desorption, scanning electron microscopy (SEM), thermo-gravimetric analysis (TGA) and compressive strength tests. According to these results, different consolidating materials could be proposed.

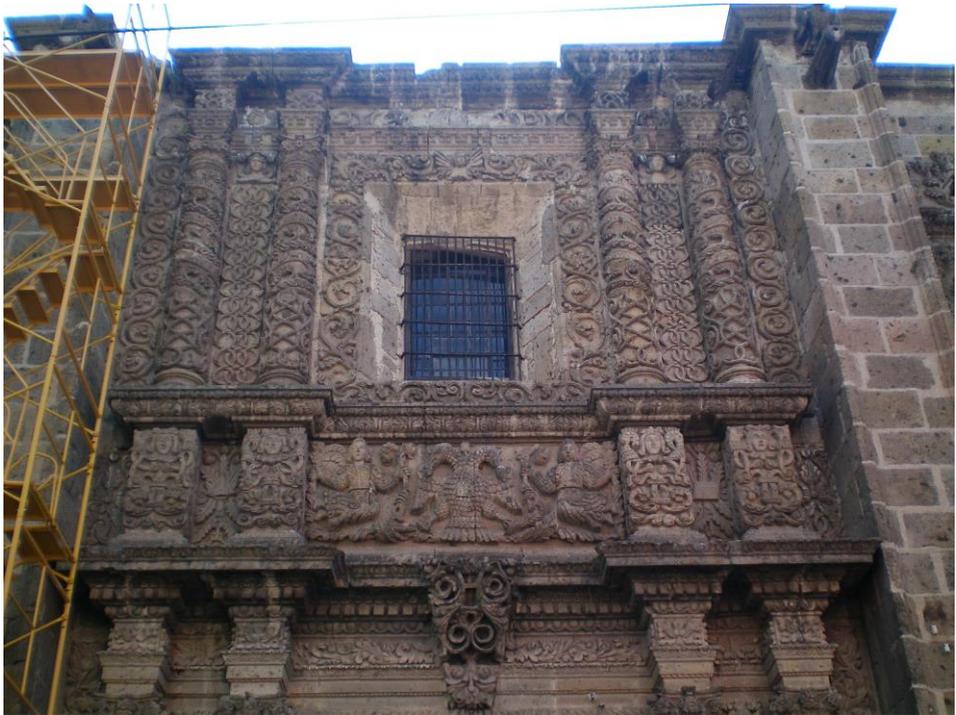
Figure 2. Detail of the façade of the Santa Mónica church in Guadalajara, Jalisco, Mexico.

During 2006, restoration procedures were held at the Santa Mónica Church, a XVII century church, located in the downtown of Guadalajara (figure 2). The church was built with yellow and white tuff. The types of degradation present were salt efflorescence, erosion, exfoliation, biological deterioration and also thermal expansion at the top of the building and anthropological factors such as loss of material due to collisions with the public transport (Jáuregui 2008).

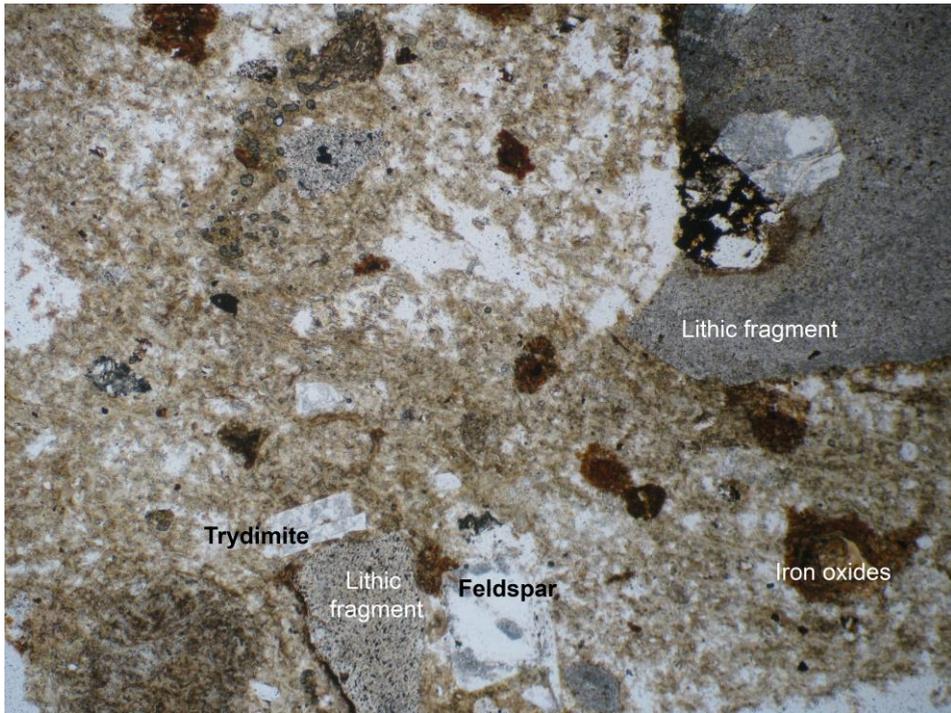
Figure 3. Petrographic images of the altered yellow tuff.

These phases were also observed in the petrographic studies where the silicon dioxide matrix is present with crystals of sanidine and other alkali feldspar, also lithic materials were present which are characteristic of volcanic explosions (figure 3). In the altered tuff an increase of iron oxides was evident, which was in agreement with the colorimetric measurements.

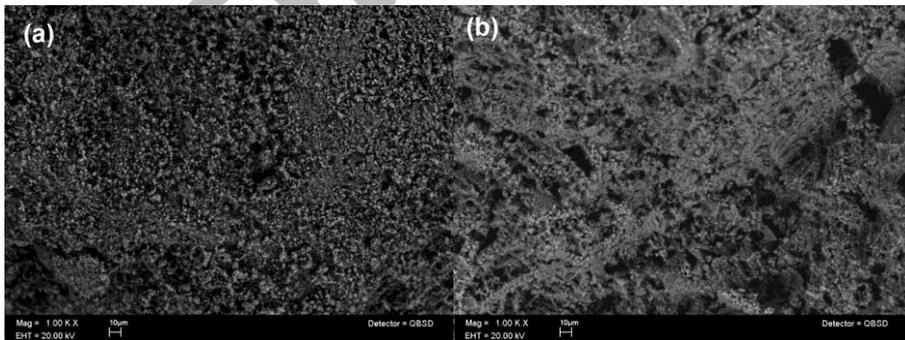
Figure 4. SEM images of the consolidated white tuffs. A) Aluminosilicate compound B) Silicate commercial compound.

The SEM images of the consolidated stone with the silicate compound after five months in accelerated aging shows that the consolidant forms SiO_2 networks on the surface of the stone, while in the tuff consolidated with the synthesized product it is not possible to distinguish the original from the consolidant (figure 4).
