CRUST FORMATION PROCESSES ON ARCHAEOLOGICAL MARBLE, CONSERVATION METHODOLOGY AND TREATMENT EVALUATION

Nikolaos-Alexis Stefanis and Panagiotis Theoulakis

*Technological Educational Institute of Athens, Department of Conservation of
Antiquities and Works of Art, Athens, Greece*

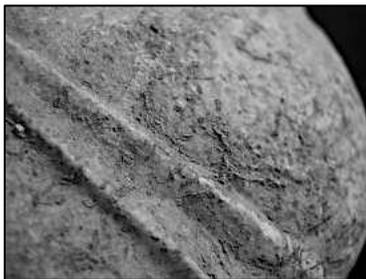
Figure 2. Photomicrograph of the surface of the marble.

The main characteristic of these depositions is the form in which they appear (Figures 2 and 3). They were found in several fragments after the removal of loose soil deposits. In some cases two layers were identified. The upper layer with thickness of 50-100 μm , which is more compact, and the lower layer with thickness of 150 μm containing confined grains of calcitic, silicious composition along with aluminosilicates (Figures 4 and 5).

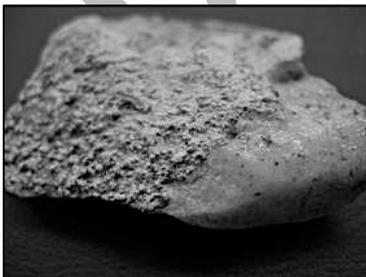
Figure 6. Photomacrograph of the encrustation (case 1) on the surface of the marble.

Case 1: These are hard, compact crusts of mainly calcitic composition with silicious material. Their main characteristic is their hardness and the relief in which they appear (Figure 6). Their thickness varies from 150 to 900 μm . In some cases two characteristic layers can be distinguished. The upper layer that is compact and has a thickness between 150 and 300 μm . In most cases a characteristic stratigraphy can be identified with alternating layers of calcite and quartz (Figures 7 and 8). The lower layer, where grains of calcite and quartz are confined (Figure 9). Its thickness ranges from 150 to 600 μm . In some cases, the trapped grains are large, measuring up to 500 μm . In general, the boundaries between the layers described and the stone substrate are quite clear.

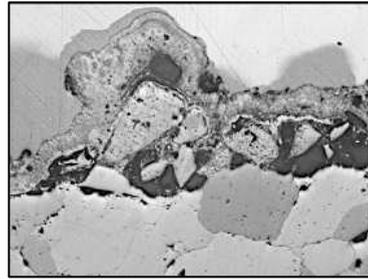
Figure 9. Light Microscopy //Nichols. Two deposition layers can be identified as well as the grains of calcite and quartz.

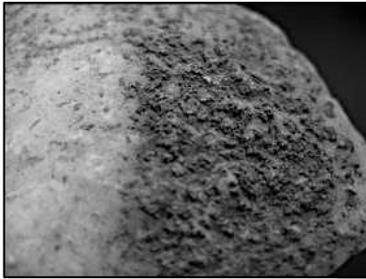
Figure 10. Photomicrograph of the encrustation (case 2) on the surface of the marble

Case 2: These are encrustations of ferric and aluminosilicious composition with a maximum thickness of 80 μm with an alternating calcitic layer, which is relatively compact. They present a maximum thickness of 200 μm and in most cases the limits with the stone substrate are very clear (Figures 10 and 11).
