## GREENING STONE CONSERVATION: EXPLORING THE PROTECTIVE ROLE OF PLANTS AND MICROBES

Heather Viles<sup>1</sup>

**12th International Congress on the Deterioration and Conservation of Stone  
Columbia University, New York, 2012**

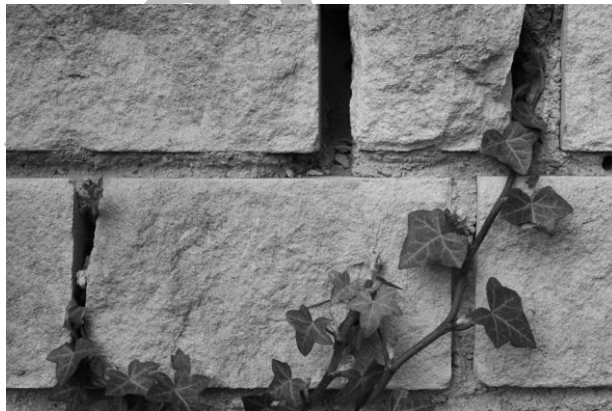
**Figure 1.** Ivy shoots exploiting defects in test wall, Wytham Woods, near Oxford, UK.

One of the problems faced by attempts to identify the exact roles of ivy, and thus in evaluating whether it has net bioprotective or biodeteriorative capabilities, is knowing how deteriorated the stonework was before the ivy grew. It is also difficult to find circumstances where objective comparisons can be made between ivy-covered and bare walls, which are identical in all other aspects. These problems can be circumvented through the use of specially constructed test walls. However, such studies require enough time for ivy to become established and climb up the wall. As part of the English Heritage-funded research, a wall was built in August 2007 in Wytham Woods, near Oxford in England. Constructed of Elm Park limestone with lime mortar joints, the wall consists of 4 faces (1.2 m wide and 2 m high) facing N, S, E and W around a central core. Each face had a series of defects and voids built into it, to encourage ivy roots and shoots to grow into the wall. After almost 5 years the ivy is now well-established, and provides many opportunities to observe contact between aerial rootlets and 'real' roots and the stonework (see Figure 1).

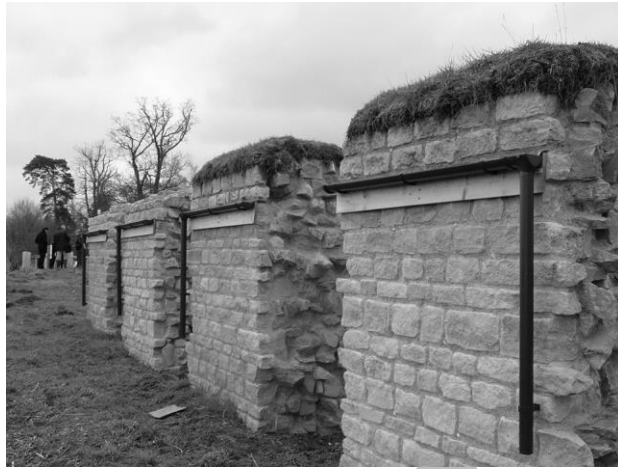
**Figure 2.** Soft and hard capped test walls, with gutters and down pipes to collect runoff, Wytham Woods, near Oxford, UK.

Testing the multiple hypotheses of soft capping's positive and negative impacts is difficult. On real ruined walls with soft capping, which has established naturally or by human actions, it is difficult to make objective comparisons between soft capped and non-soft capped or hard capped areas as the nature of ruined walls is very variable, and the deterioration status often unknown (Sass and Viles 2006). As with ivy, a good solution is to build specially designed test walls (some with soft capping and some with hard capping), and monitor thermal and moisture regimes and the rate and nature of deterioration. Four such test walls have been built in Wytham Woods, near Oxford, from Cotswold limestone and lime mortar joints (Figure 2). Each wall consists of a rubble core with dressed stone faces. The walls were built and capped in 2007, and have been monitored ever since. Hard capping was created using stone and lime mortar. The soft capping trialed consisted of around 5 cm of screened loam soil, with turf cut from surrounding grassland. In 2011, small plugs of sedum were added to the edges of the turf capping, as harsh environmental conditions had led to some dieback and erosion of the turf. Sedums are known to be able to survive under dry conditions.

Over a 3-year period, comparative observations have been made of the moisture regimes on and within the hard capped and soft capped test walls, using a range of methods including hand-held moisture meter surveys, wooden dowels, 2D resistivity, instrumentation with gutters and down-pipes to collect runoff, and time-lapse photography. Surprisingly complex moisture regimes have been observed.

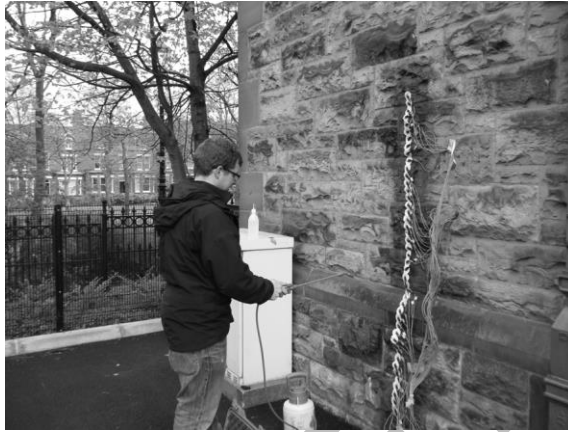
**Figure 3.** Monitoring moisture uptake on sandstone wall patchily covered with green algae using 2D resistivity surveys, Belfast, Northern Ireland.

An EPSRC-funded research project has focused on evaluating the roles of green algal biofilms on the deterioration of sandstone, using field monitoring on urban walls in Belfast which are experiencing patchy greening. Alongside this, longer-term studies of a purpose built test wall at Derrygonnelly in western Northern Ireland are in progress (although hampered by the slow development of greening). On four buildings within Belfast detailed surveys have been made of the internal and surface moisture regimes, greening and weathering status along vertical transects of around 2m in height (Figure 3). Using 2D resistivity surveys to probe the moisture regimes, in combination with

experimental wetting, we have found no evidence that green algal covered areas are wetter than bare sandstone patches. Indeed, there is evidence that green algal covered patches have a drier subsurface zone, and furthermore that they repel driving rain.
