**CONSERVATION OF ARCHITECTURAL MARBLE AT
THE NEW YORK PUBLIC LIBRARY**

Timothy Allanbrook¹ and Andrew Wilson²

¹ *FAIA, Senior Principal, Wiss, Janney, Elstner Associates, Inc.*

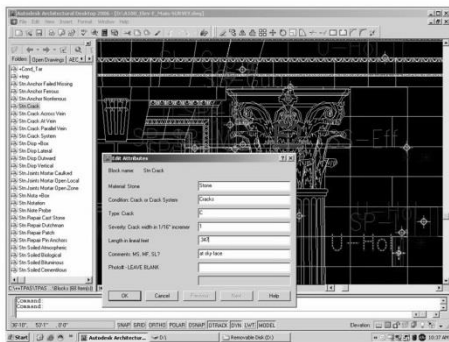
Figure 4. Screen capture from tablet software used to record existing conditions.

An extremely detailed series of condition descriptions were developed to assure adequate flexibility in characterizing field observations. The conditions were categorized into broad types and sub-types. Finally, the quantity and severity of distress conditions observed, and comments relevant to the particular condition, were recorded through the course of the survey (Figure 4).
