**LEARNING FROM THE PAST – A REVIEW OF TREATMENTS
CARRIED OUT TO CLUNCH IN 1985 AND FURTHER FIELD AND
LABORATORY INVESTIGATIONS INTO THE DECAY MECHANISMS**

David Odgers¹ and Trevor Proudfoot²

Abstract

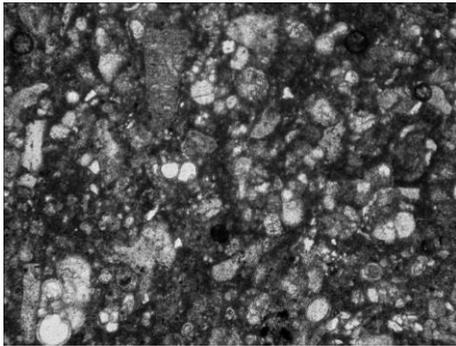
Photomicrographs of the two different types of Tottenhoe clunch are shown below (Figs 1-2). The images represent 1.22mm wide areas of the stones. The clearer and more colourless parts are crystalline pieces of shell and the darker indistinct material is lime mud. The Tottenhoe Grey (more durable) stone has a much smaller proportion of mud. A difference in particle size of the larger fractions, between the two types is clear to see. The grey variety is coarser but apparently the matrix is more compact and opaque, while the white shows a greater degree of bright speckling due to micrite particles which seem to be less closely packed than those of the grey. Although at the present magnification pores are not discernable (they are considerably smaller than the thickness

Fig 1. Photomicrograph - Tottenhamhoe (grey)

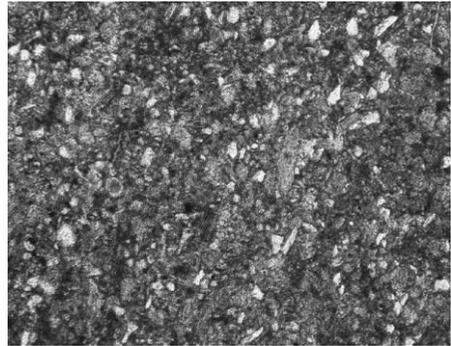
of the section, and thus obscured by overlapping grains), it would seem that the softness of the white variety could be attributed to less contact adhesion between grains and consequent greater permeability.

Fig 2. Photomicrograph of Tottenhamhoe (white)
