**EVALUATION OF CONSERVATION TREATMENTS APPLIED TO THE
STONE OF THE CATHEDRAL OF JEREZ DE LA FRONTERA (CÁDIZ,
SPAIN)**

Rosario Villegas Sánchez¹ and Fátima Arroyo Torralvo¹

**12th International Congress on the Deterioration and Conservation of Stone
Columbia University, New York, 2012**

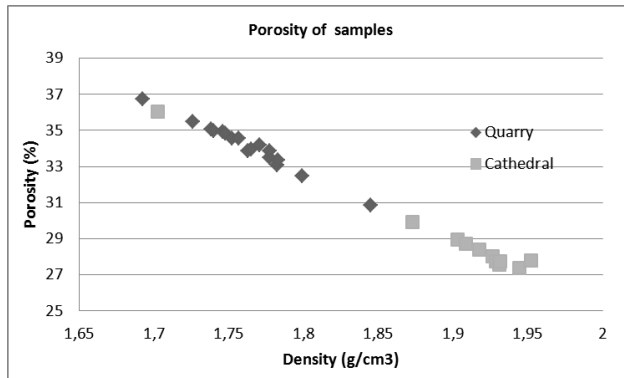
Figure 1. Porosity / density of samples

On figure 1 it can be seen the inverse linear relation between porosity and density of both types of samples, showing that density and porosity of all of them keep the same relation.

stone, to get a complete impregnation. The treatments drying process has been followed by weighing the samples daily until constant weight. In table 4, the weight increments due to conservation products applications are shown. Before and after the treatment, the total open porosity (Ontiveros, 1998) of all the samples have been measured (Figures 1 and 2).
